Planning Committee

Report of Head of Planning, Engineering and Transportation on 05-Sep-2019

Location: 414, BOSTY LANE, ALDRIDGE, WALSALL, WS9 0QF

Proposal: LISTED BUILDING CONSENT TO UNDERTAKE: 1) REMOVAL OF ROOF COVERINGS AND FIRE DAMAGED TIMBERS. 2) TAKE DOWN DISLODGED BRICKWORK. 3) REMOVAL OF LOOSE AND PRECARIOUS MATERIAL. 4) DISMANTLING OF WALL HEADS. 5) REMOVAL OF ANY LOOSE MASONRY. 6) WALLS TO BE PROPPED AND SHORED.

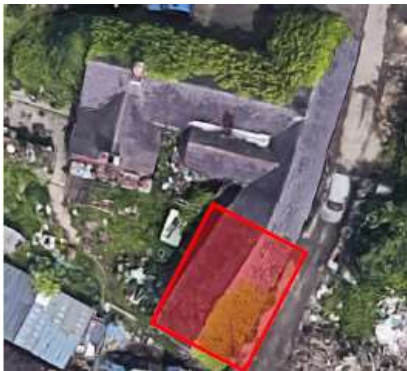
- A visual inspection was carried out on 30-05-19.
- The extent of the damage to the barn structure appears to be confined mainly to the adjoining farm building to the east with some damage extending through to the main structure.
- General cracking around the main farmhouse with likely damage and movement occurring in the building caused by the fire.
- The south portion of the roof structure to the east farm building appears to be almost completely demolished due to the fire damage.

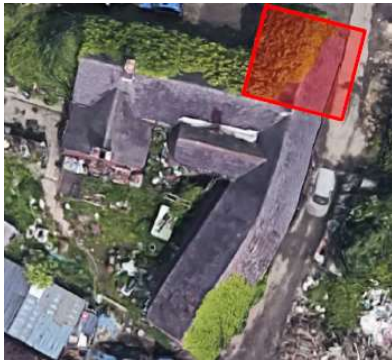
- The north portion of the roof structure to the East farm building appears to remain intact however; visual cracking and fallen tiles show signs of movement.

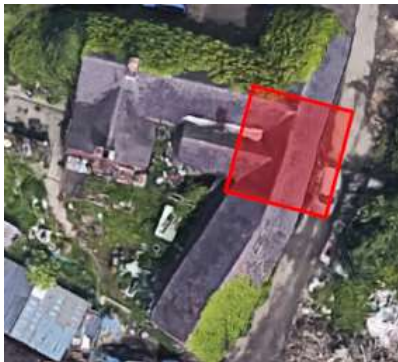
- The middle portion of the roof structure to the East farm building, which connects to the adjoining roofs of the main building, has severe damage with the main timber roof trusses exposed and burnt away.

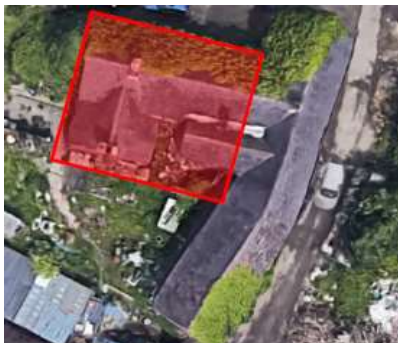
- The roof structure of the main farmhouse appears to be mainly intact from a visual stance with only a few tiles fallen and missing.

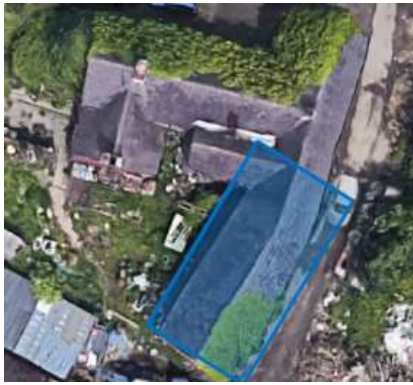
- The south portion of the East farm building walls have been severely damaged by the fire. Twisting and bowing of the walls has taken place causing large cracking and instability. The absence of these walls has caused the adjoining walls to crack and move due to the loss of support in these areas.

- The unsafe south section of the East Farm building should then be demolished with mechanical plant kept a safe distance from the building. It is advised that specialist equipment and machinery is used in order to limit the danger to parties carrying out the work, for example using long reach machinery where possible.

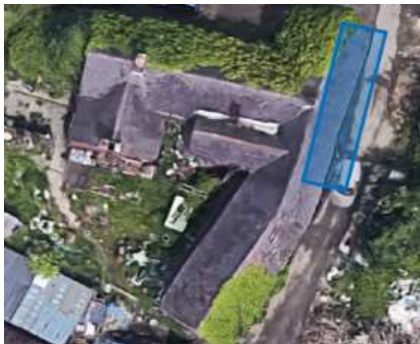
- The north portion of the East farm building walls have been damaged and show signs of movement with associated large cracking of the walls, especially around window heads and doors.

- A suitably qualified contractor should be appointed, experienced with fire damaged buildings and their repair.
- The north section of the East Farm building which is considered stable is safely scaffolded and propped up extent to be agreed. Scaffolding and propping are to be designed by a competent Engineer.

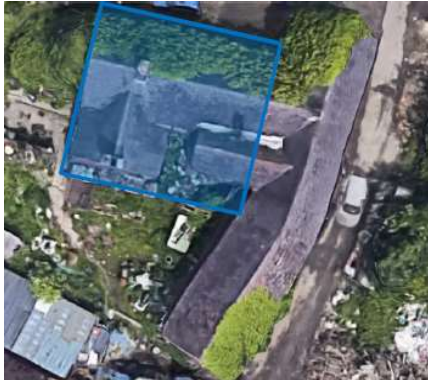
- The main farmhouse walls appear to have much less damage but show signs of small cracking.
