Walsall Pupil Referral Unit

Options Appraisal

RIBA 1 Report

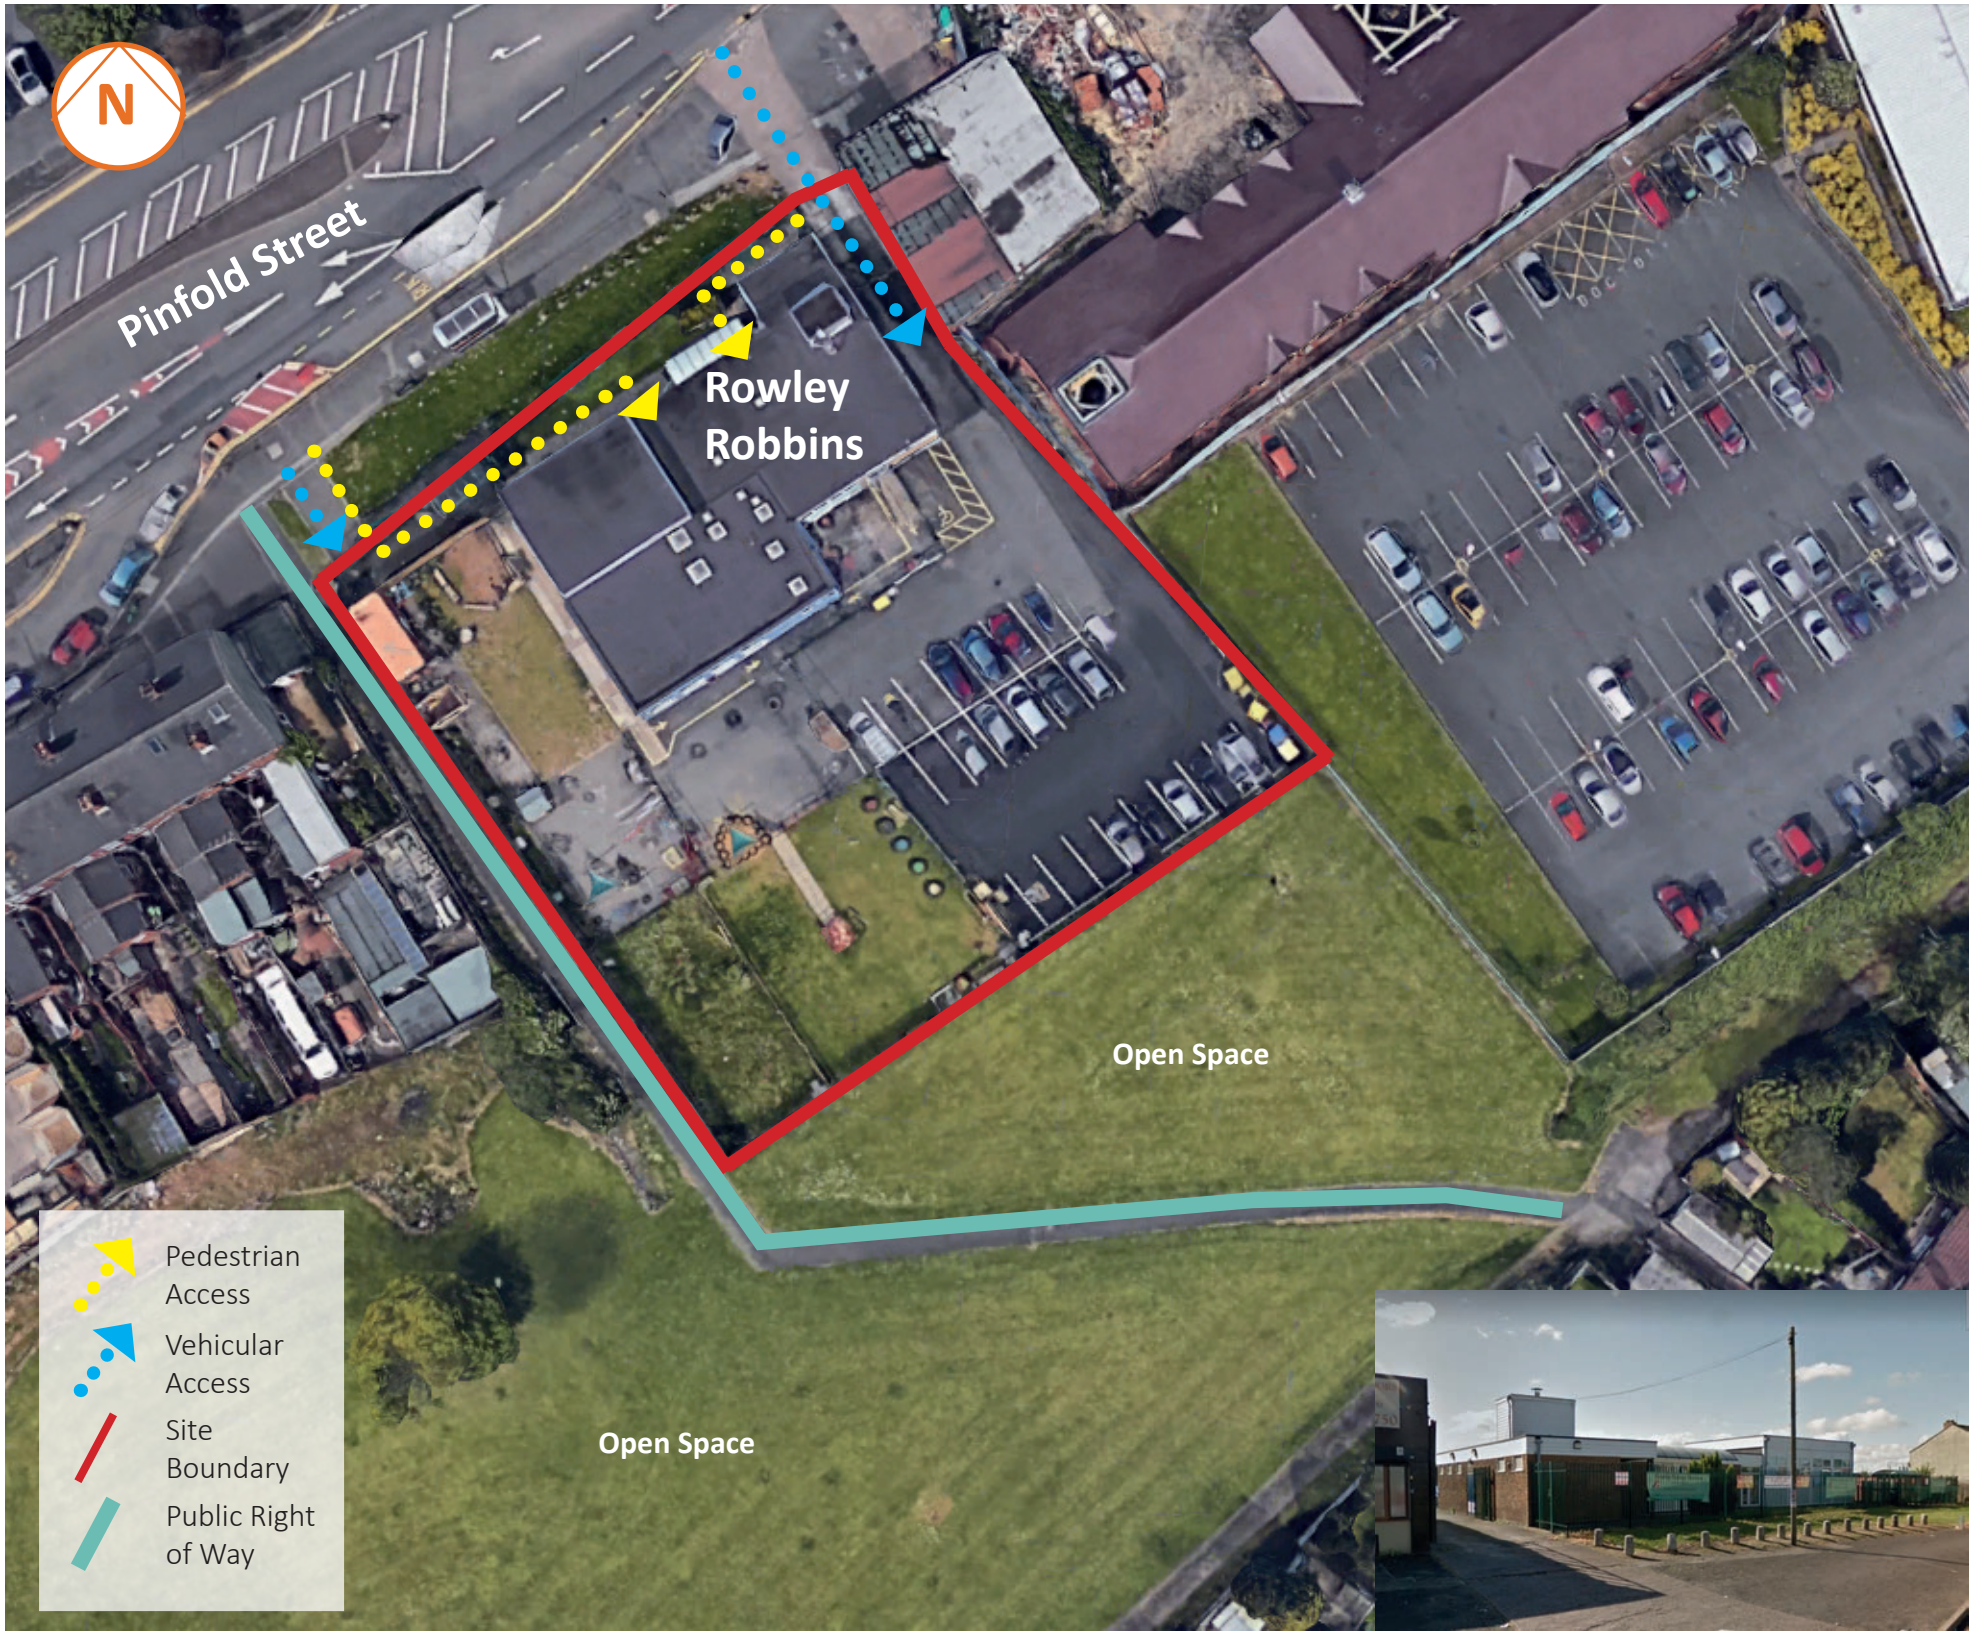
Existing site layout

The main vehicular access is via Pinfold Street (A4038) with a secondary access, currently blocked, also via Pinfold Street. The main pedestrian route is also accessed via Pinfold Street.

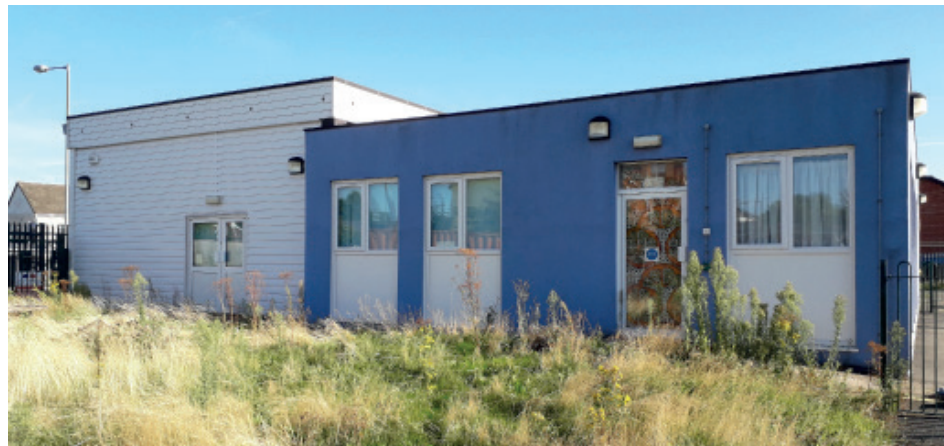
View of South West Elevation

Arcadis visited the site on 13 September 2018 with access to both external and internal spaces. It is understood the original single storey building was both modernised and extended in 2005. The single storey blue rendered extension (shown in the image below) included additional nursery teaching space and WCs. The building fabric is currently in reasonable condition and is water tight.

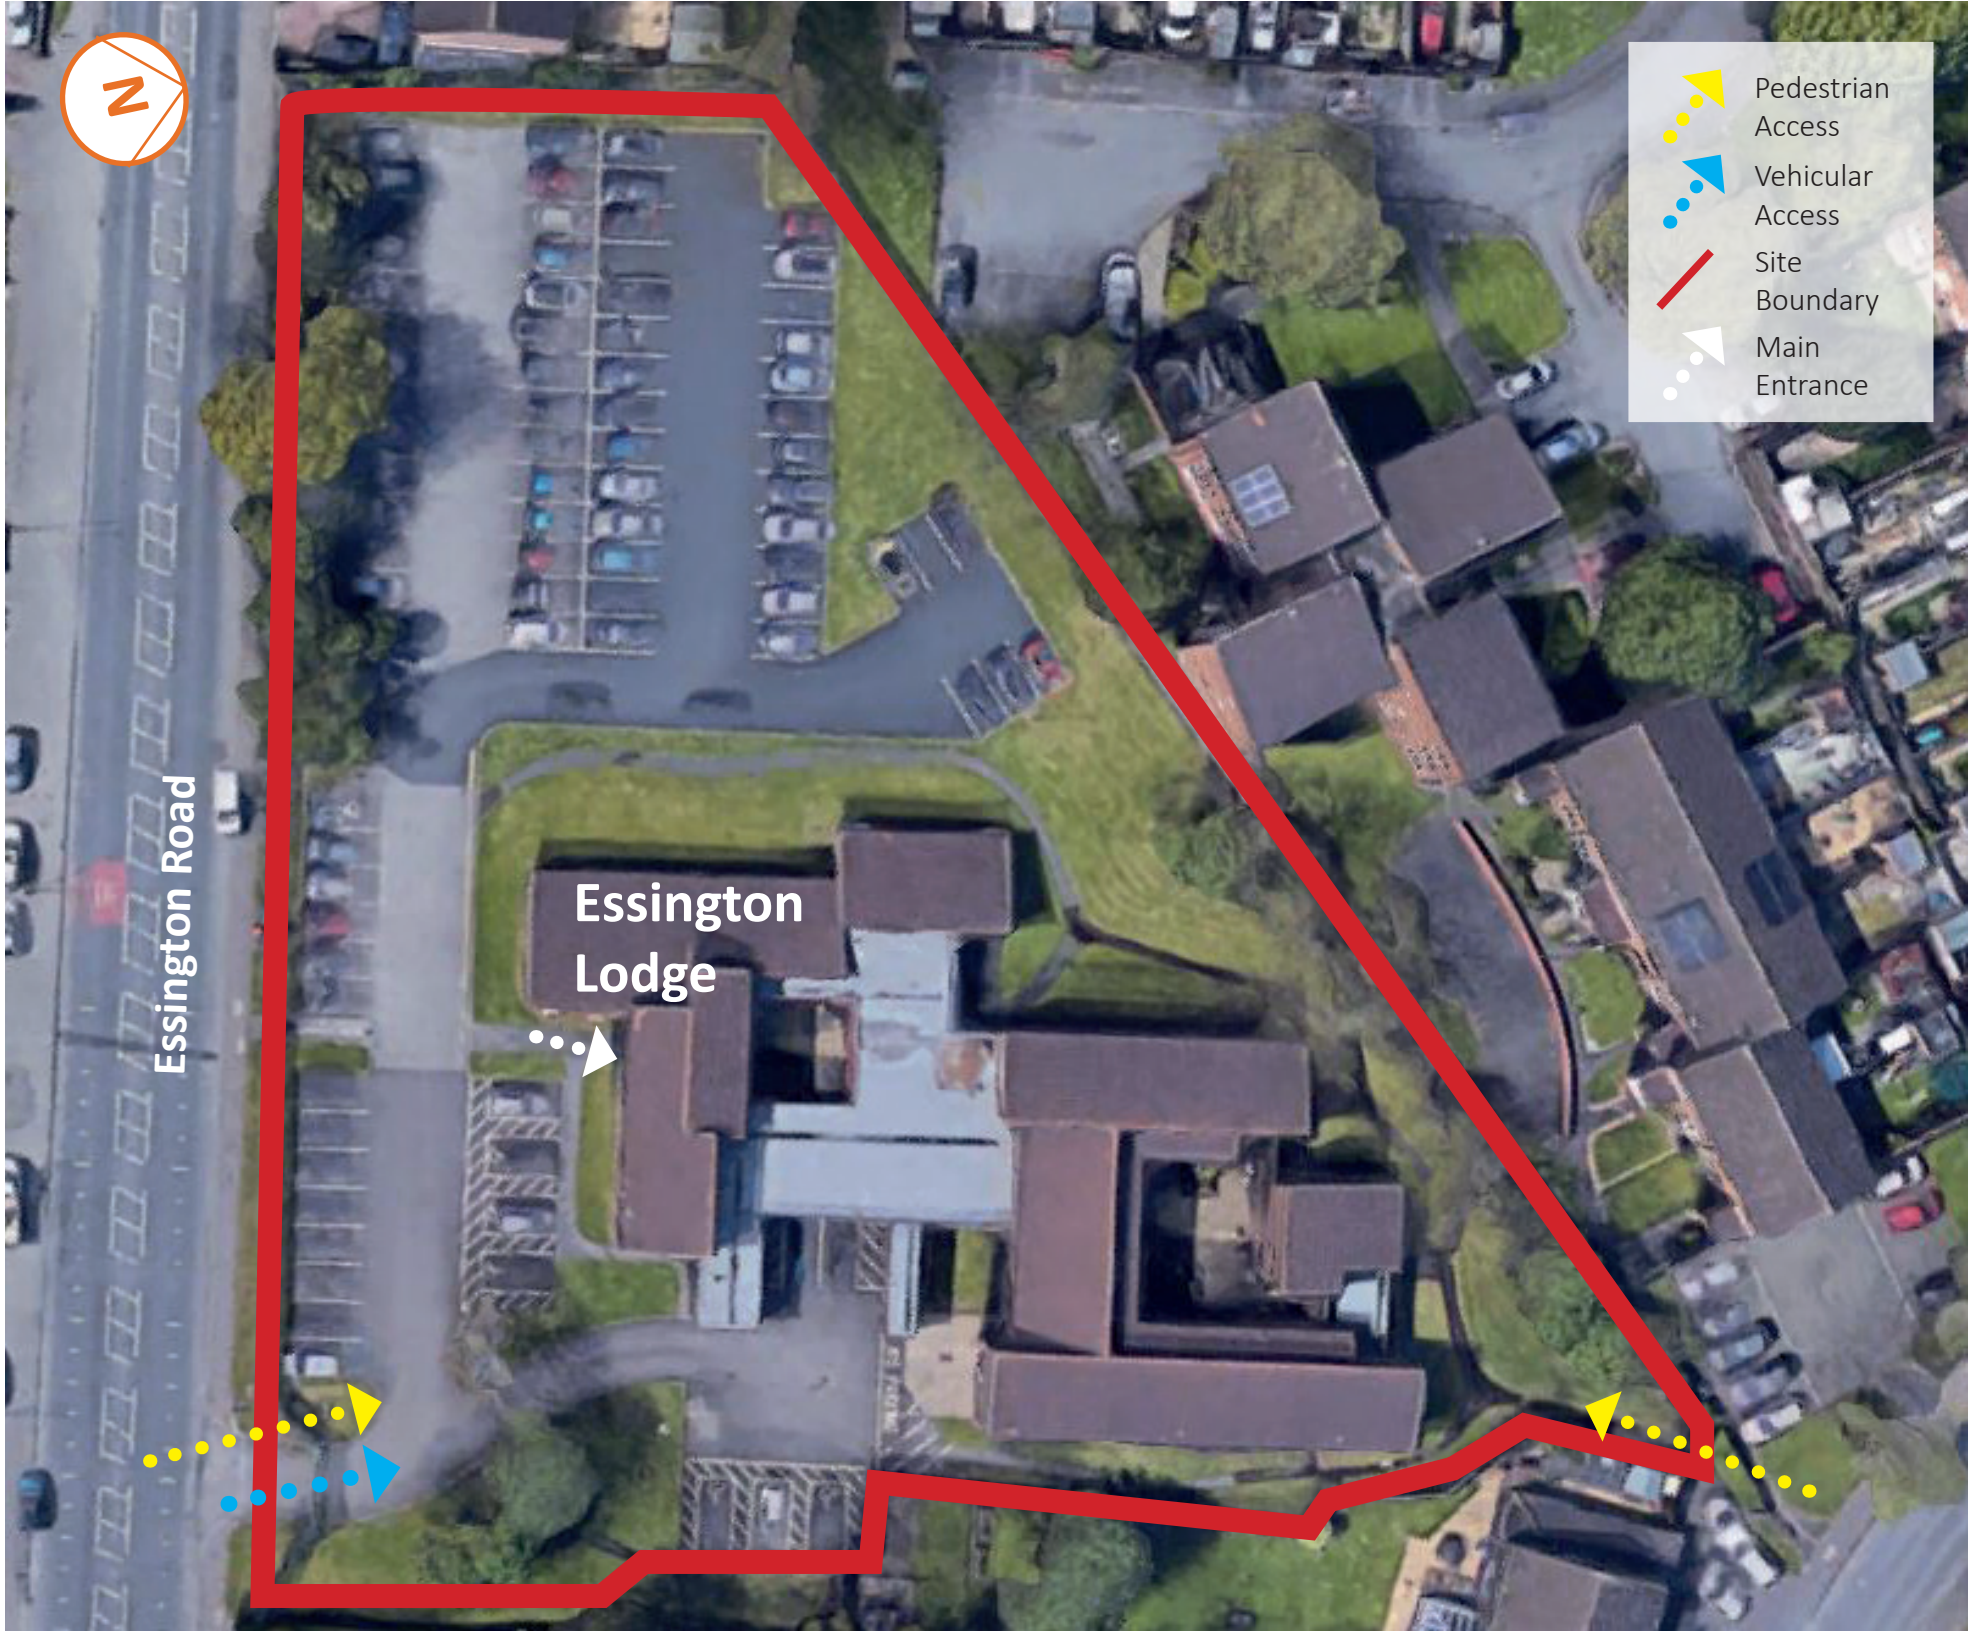
Existing site layout

The building is predominantly single storey. There are two independent areas of the building which are accessible from several independent internal stairs. The internal layout doesnt have clear lines of vision and a range of room sizes. In order to operate as a PRU it would require

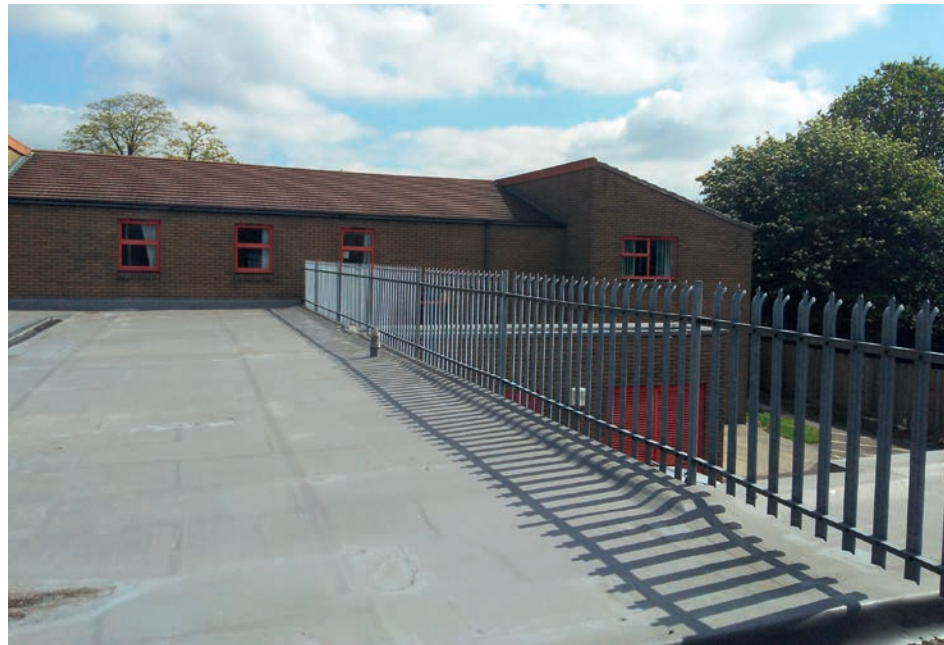
The existing building is of traditional construction, built with yellow fair faced bricks laid to a stretcher bond pattern, with brick feature sills. The brickwork and pointing is generally in good condition, with the exception of the pointing at the damp proof course, which is deteriorated and needs repointing in a number of areas. The brickwork to some of the door thresholds is also defective to some areas and requires remedial works.

The mono pitched roof structures are assumed to be timber framed, and are finished with plain tiles, with PVC dry verge trims. The roof coverings are in fair condition, though need further detailed inspections.

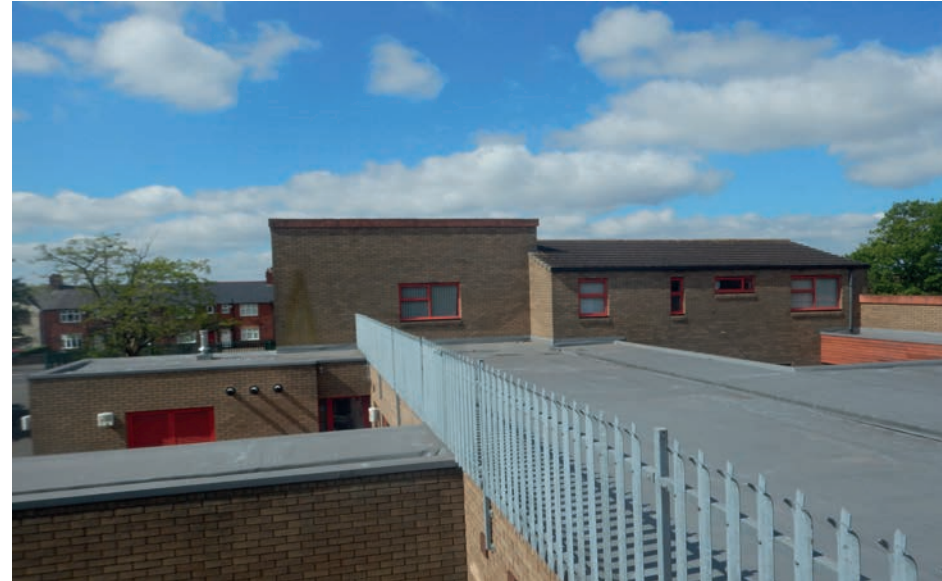
In isolated areas the verge trims are missing and are beginning to discolour due to aging and UV degradation, and replacement would be recommended. The rainwater goods are PVC, which are again discoloured due to aging and UV degradation. Replacement is recommended with modern polyester powder coated aluminium for durability and reduced long term maintenance expenditure. Anti-climb features are also present, restricting access to the pitched roofs. Insulation within the roof void areas could not be verified, and opportunities may exist to improve the thermal performance of the building with increased insulation thicknesses.

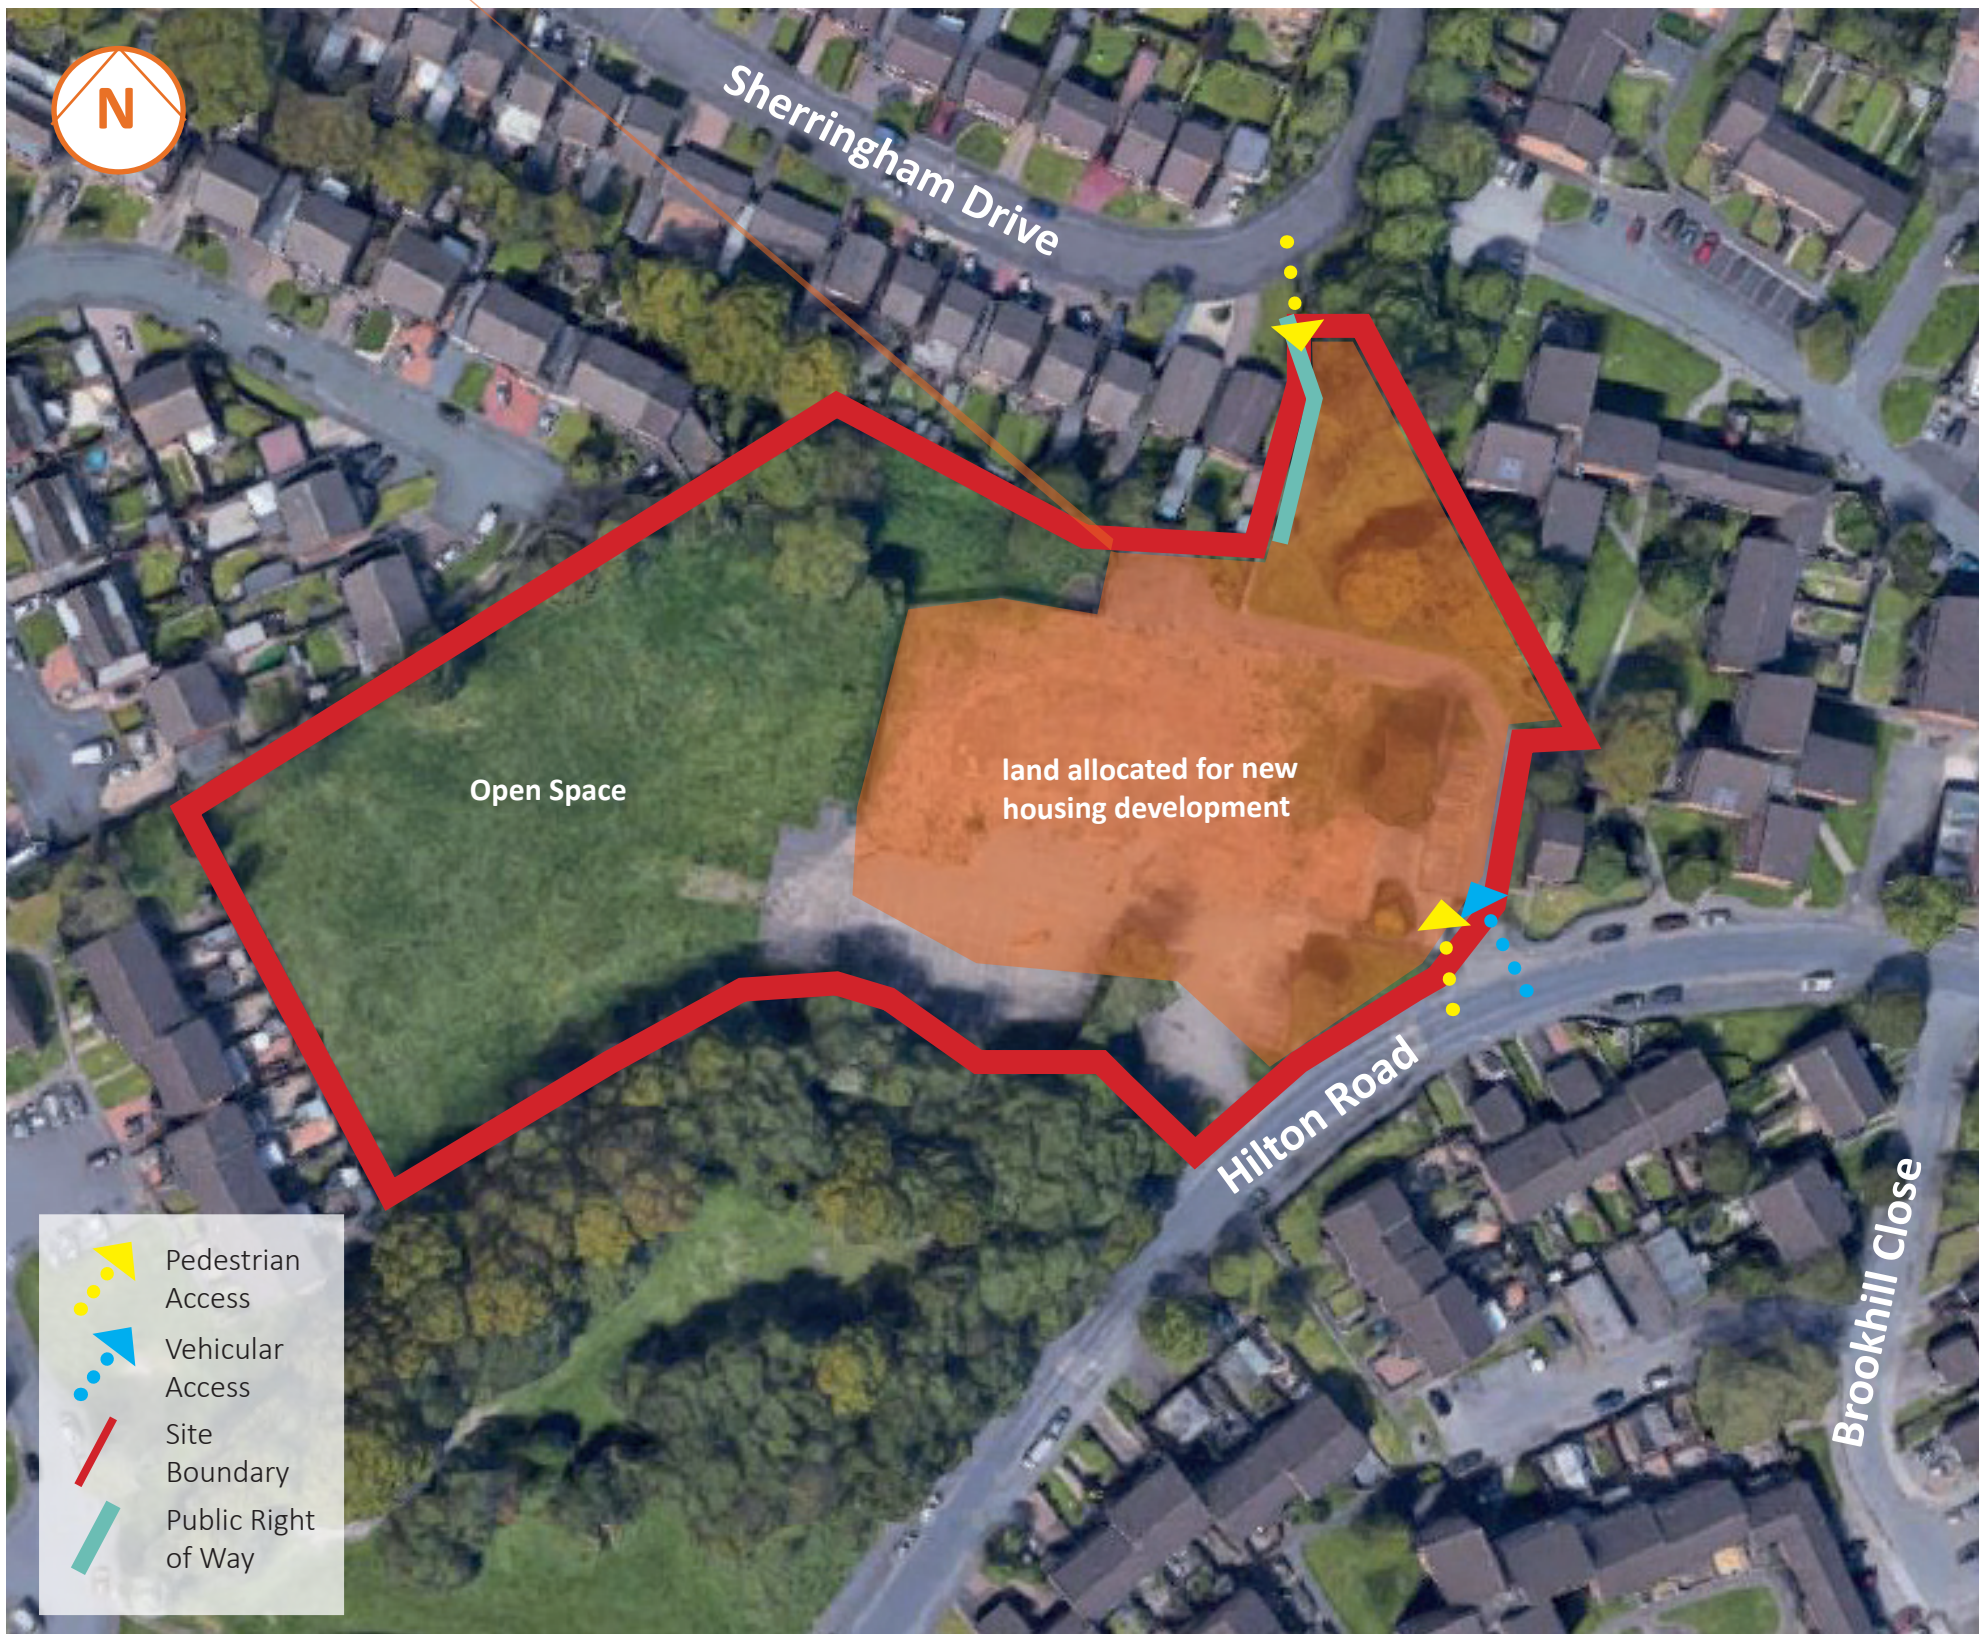
Existing site layout

Housing is located to the north, east and west of the site boundary. A public right of way is present from the north of the site to east of 46 Sherringham Drive which has been noted on the adjacent site plan. Dense woodland is located to the southern boundary of the site.

The area of the site located to the west is grassed. The former footprint of the site is located to the east. The main entrance is located off Hilton Road. The site within its fenced boundary is relatively flat.

The existing car park area is located to the south of the site within close proximity to the entrance.

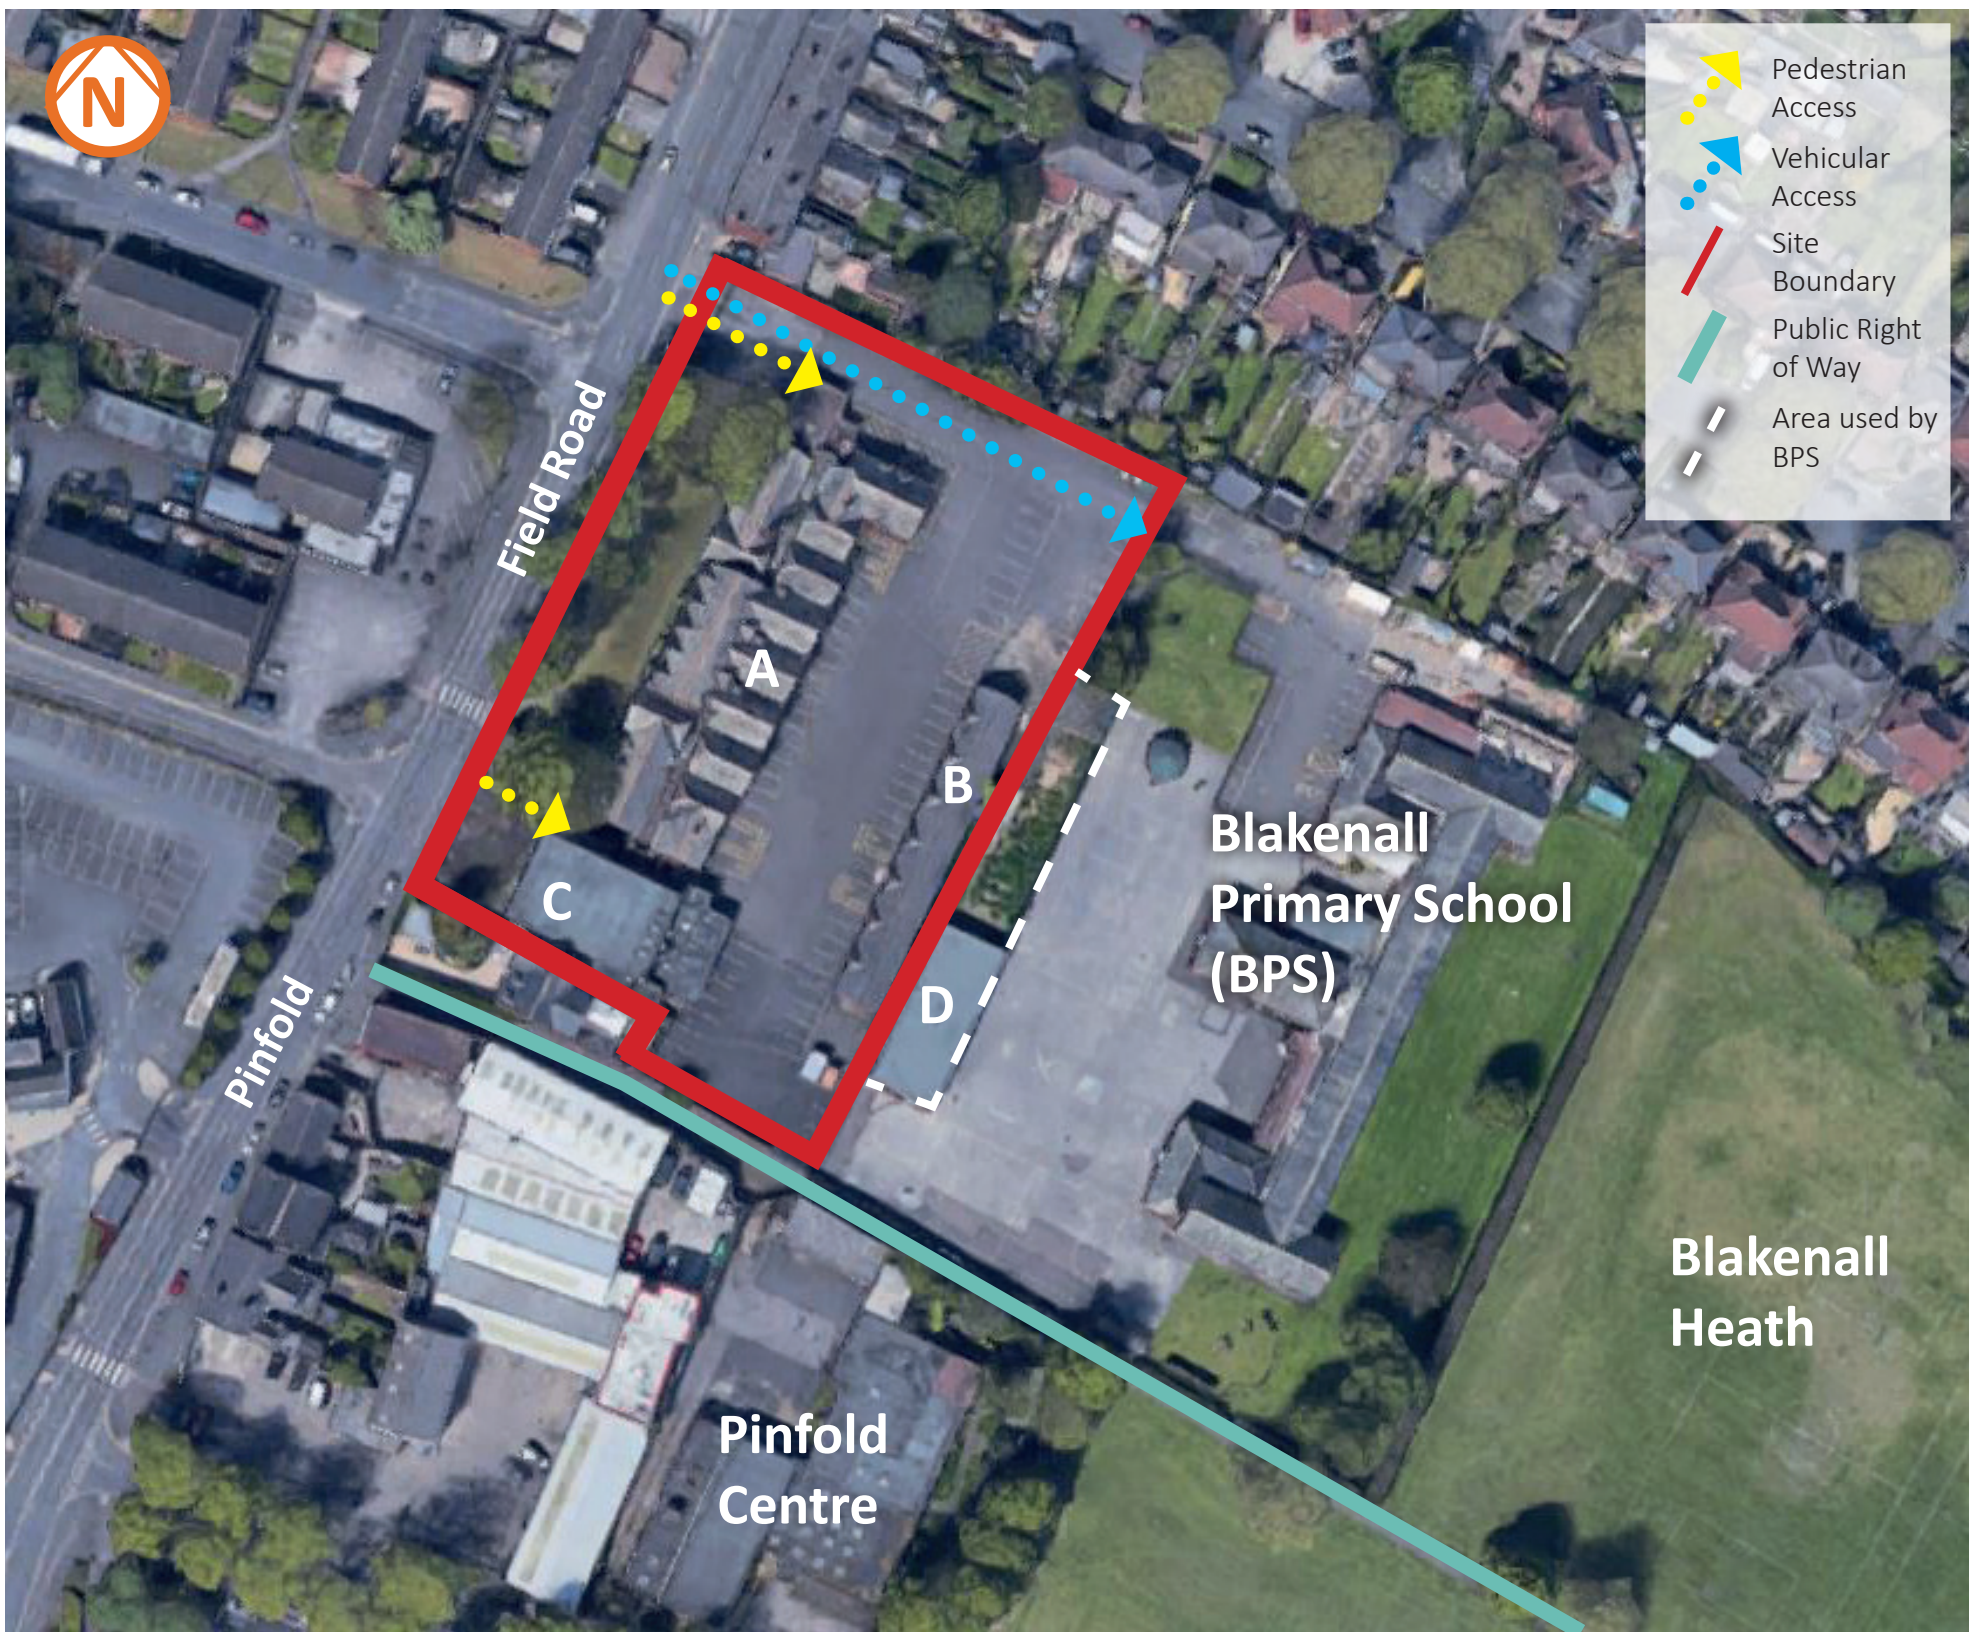
Site Location Plan

The site shares a vehicular access with the adjacent primary school. The main vehicular access is via Field Road. The main pedestrian route is also accessed via Field Road. Secondary pedestrian entrances are noted on the adjacent map.

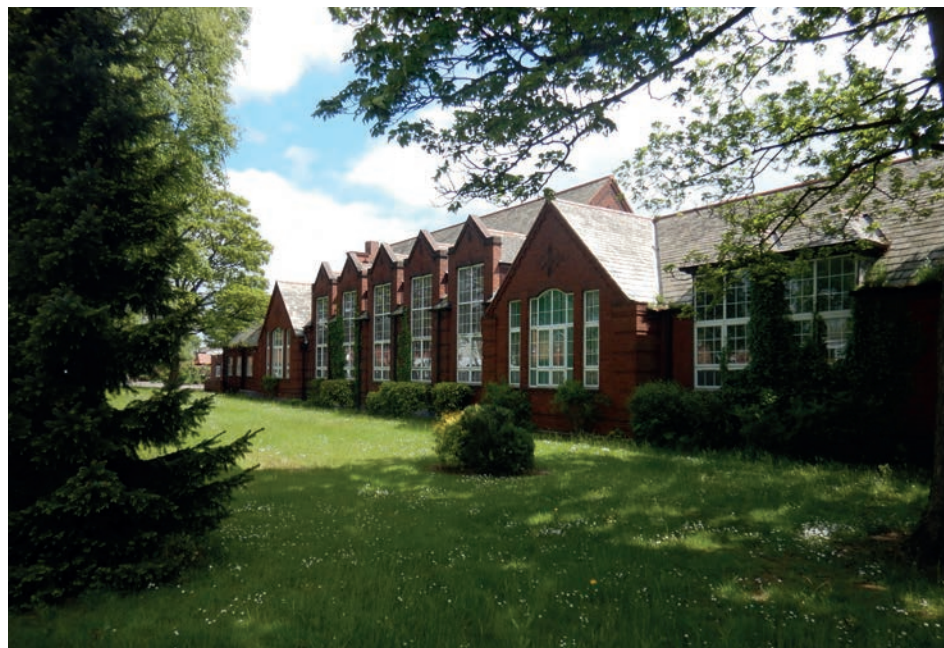
Front Elevation of Block A facing Field Road

The existing buildings are of traditional construction, built with red fair faced bricks laid to an English bond pattern, with brick corbel, dentil and other architectural features. The brickwork is in fair condition though cracking was noted; however, the mortar pointing has failed in numerous locations and needs extensive repointing. Access for repointing to the rear elevation of the smaller of the two buildings is restricted by fencing which will require removal and reinstatement to facilitate any works. As the external walls are solid masonry with no cavity, they will have limited insulating qualities. Plant growth is evident to a number of areas, in particular around rainwater hopper heads, which needs remediation works.

The pitched roof structures are assumed to be timber framed, with steel tie bars and are finished with natural slates and clay ridge tiles.

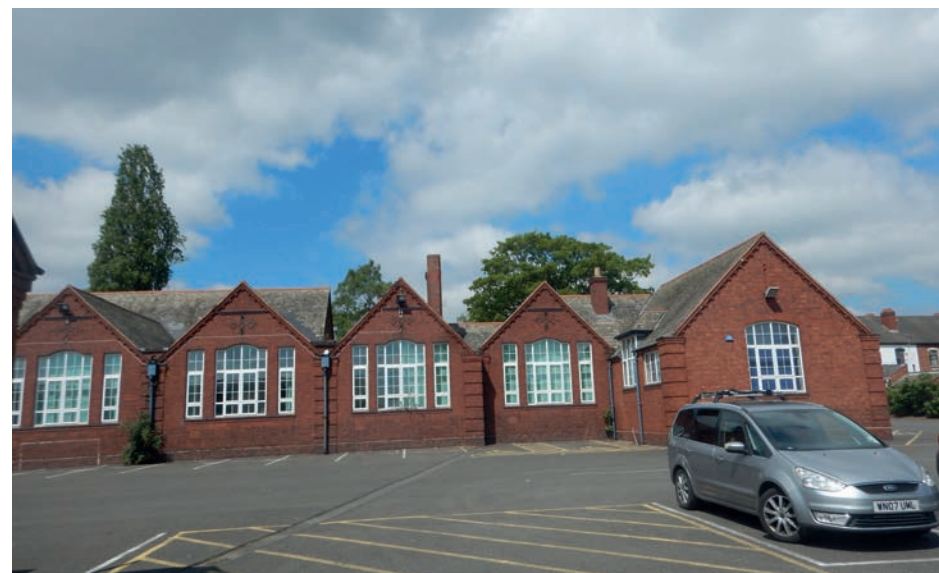
Rear Elevation of Block A facing hard play / car parking

Patch repairing has been undertaken with fibre cement slates, which are unaesthetic when viewed against the original natural slates. The roof coverings are in fair condition, though further detailed inspections are highly recommended as numerous defects are likely to exist, due to the extent of the internal water penetration issues noted. Timber decay as a result of water penetration to the roof structure or similar may also be present, which will need to be investigated further. The rainwater goods are cast iron and are in poor condition, and replacement is recommended with modern polyester powder coated aluminium for durability and reduced long term maintenance expenditure. Insulation

within the roof void areas could not be verified, and opportunities to improve the thermal performance of the building with increased insulation thicknesses may exist.

The larger block has a number of flat roof areas which are believed to be all weathered with felt. Anti-climb razor spikes are also installed which restricts access to the flat roof areas. Due to the extensive water penetration issues internally, and directly beneath these areas, repairs will be likely which will need verification via further inspections. Rooflights are also present to the central flat roof area. These rooflights are also suspected to be defective due to the water penetration issues noted in close proximity. The level of insulation to the flat roof areas could also not be ascertained from a visual inspection, and opportunities may exist to improve the thermal performance of the building with increased insulation thicknesses, though this will result in replacement roof coverings.

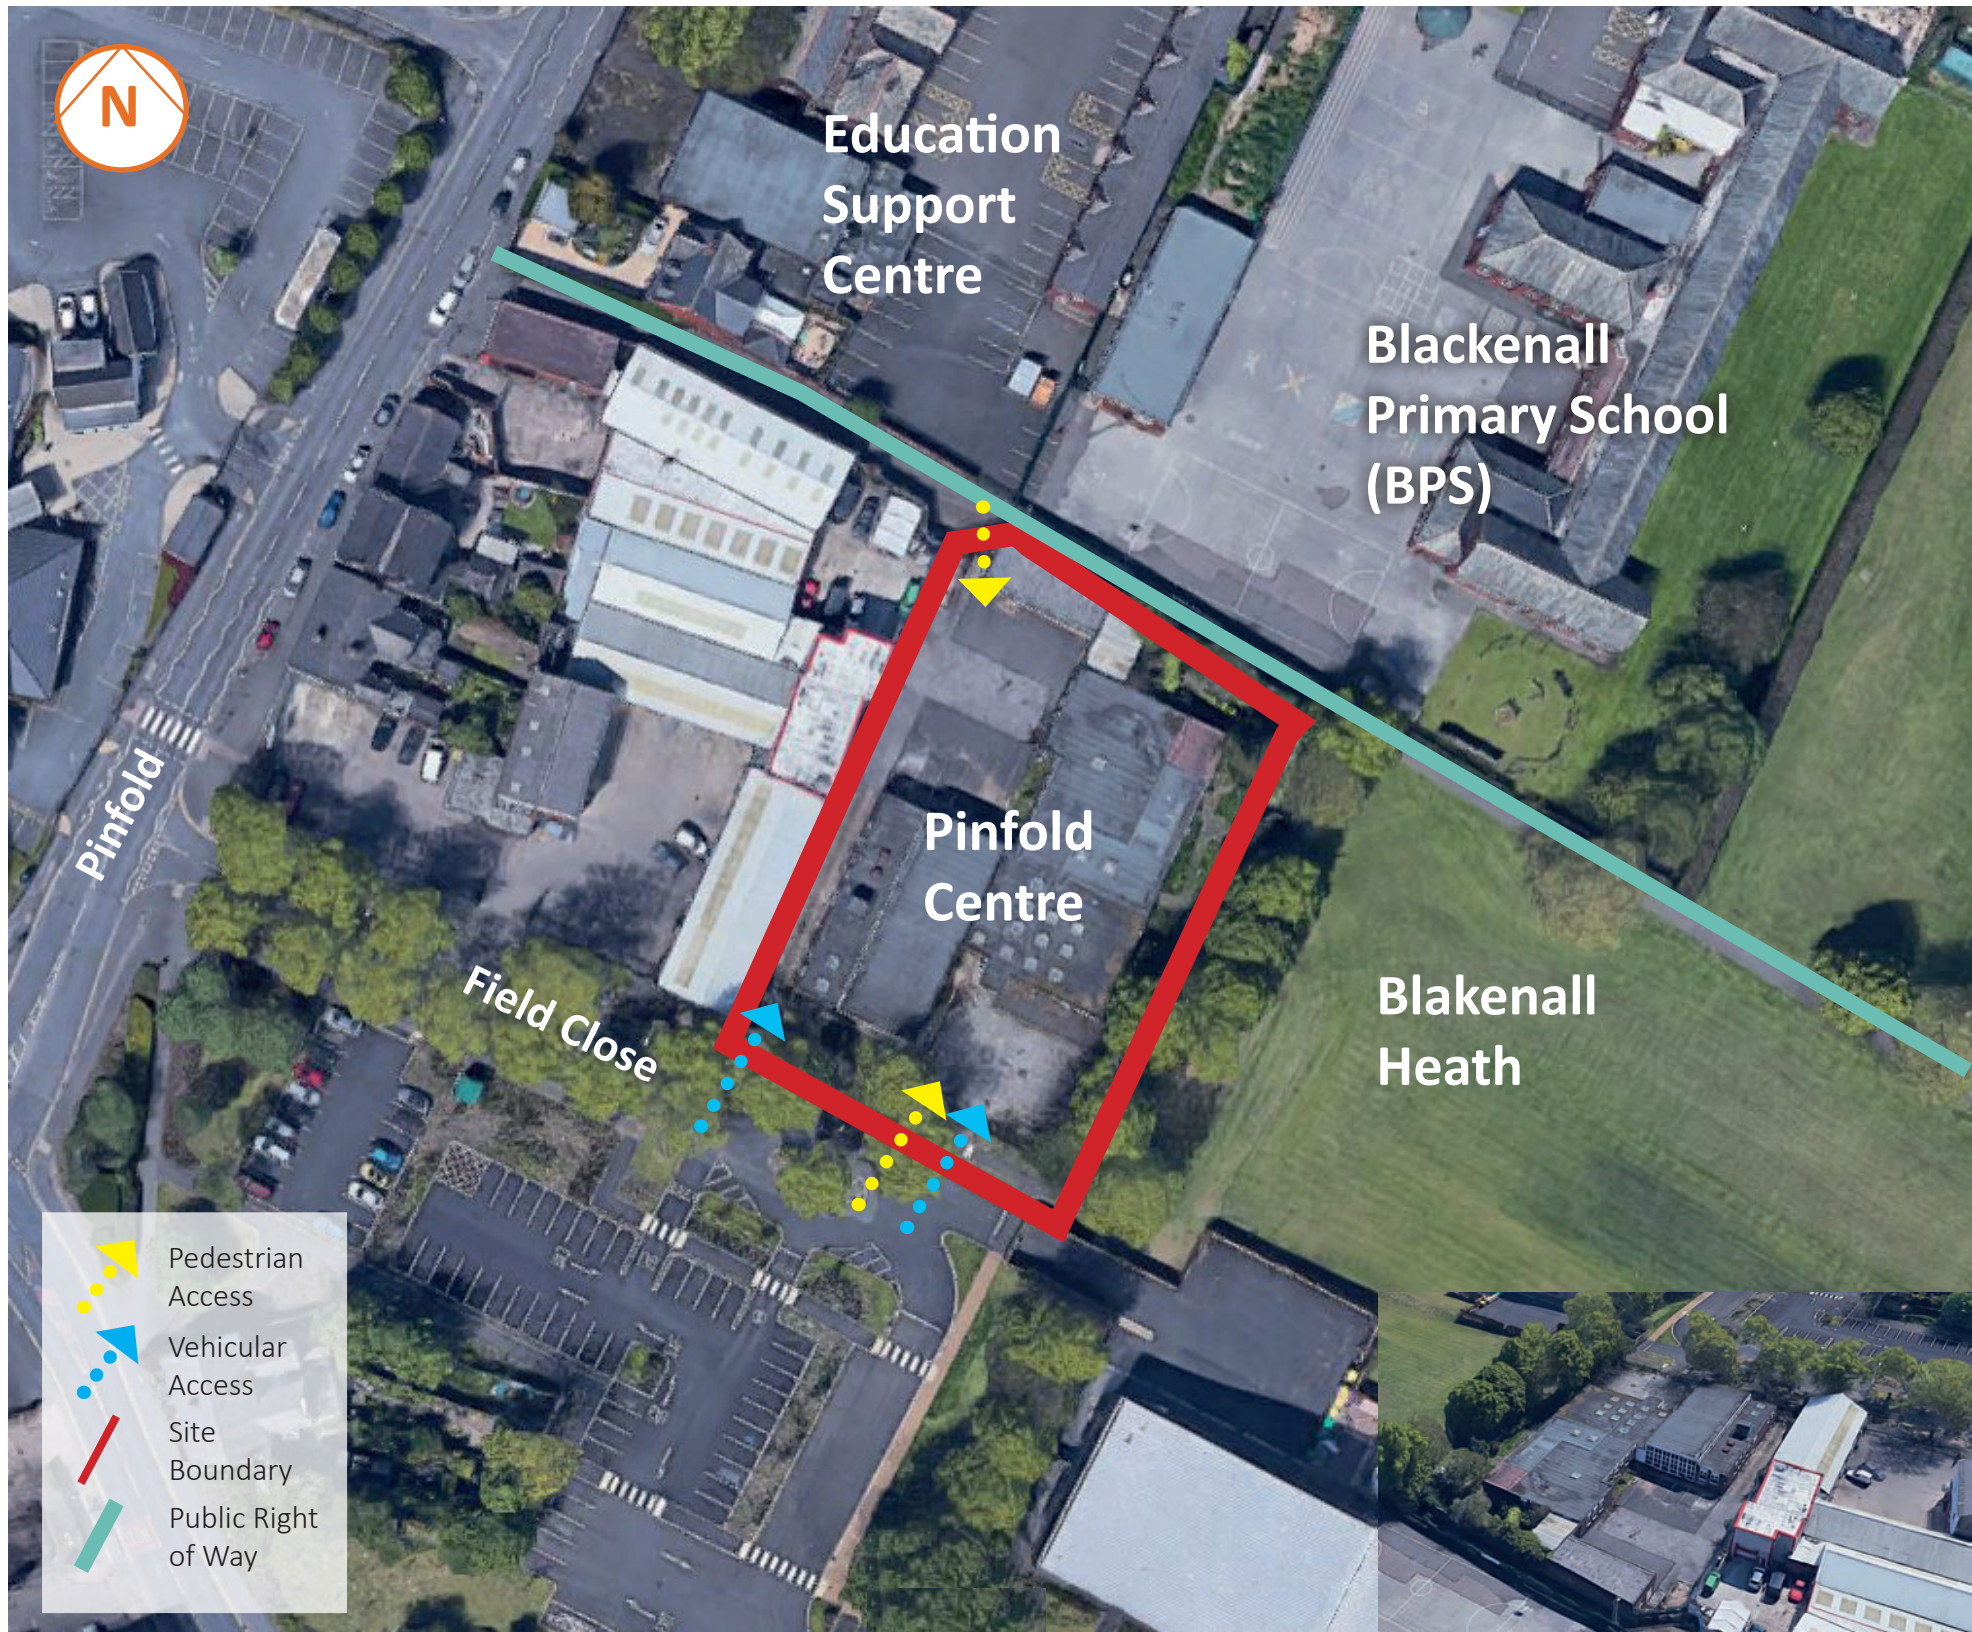
Existing site layout

The former day care centre building is heavily vandalised and subject to arson. The building was considered by the client to be uneconomical to refurbish. Further to this it was determined the site was too small for a 60 or 80 place PRU. Due to limited external area and reduced efficiencies to deliver a split site it was agreed with the client team on the 10th June to eliminate this site due to unsuitability.
