Walsall Pupil Referral Unit

Options Appraisal

RIBA 1 Report

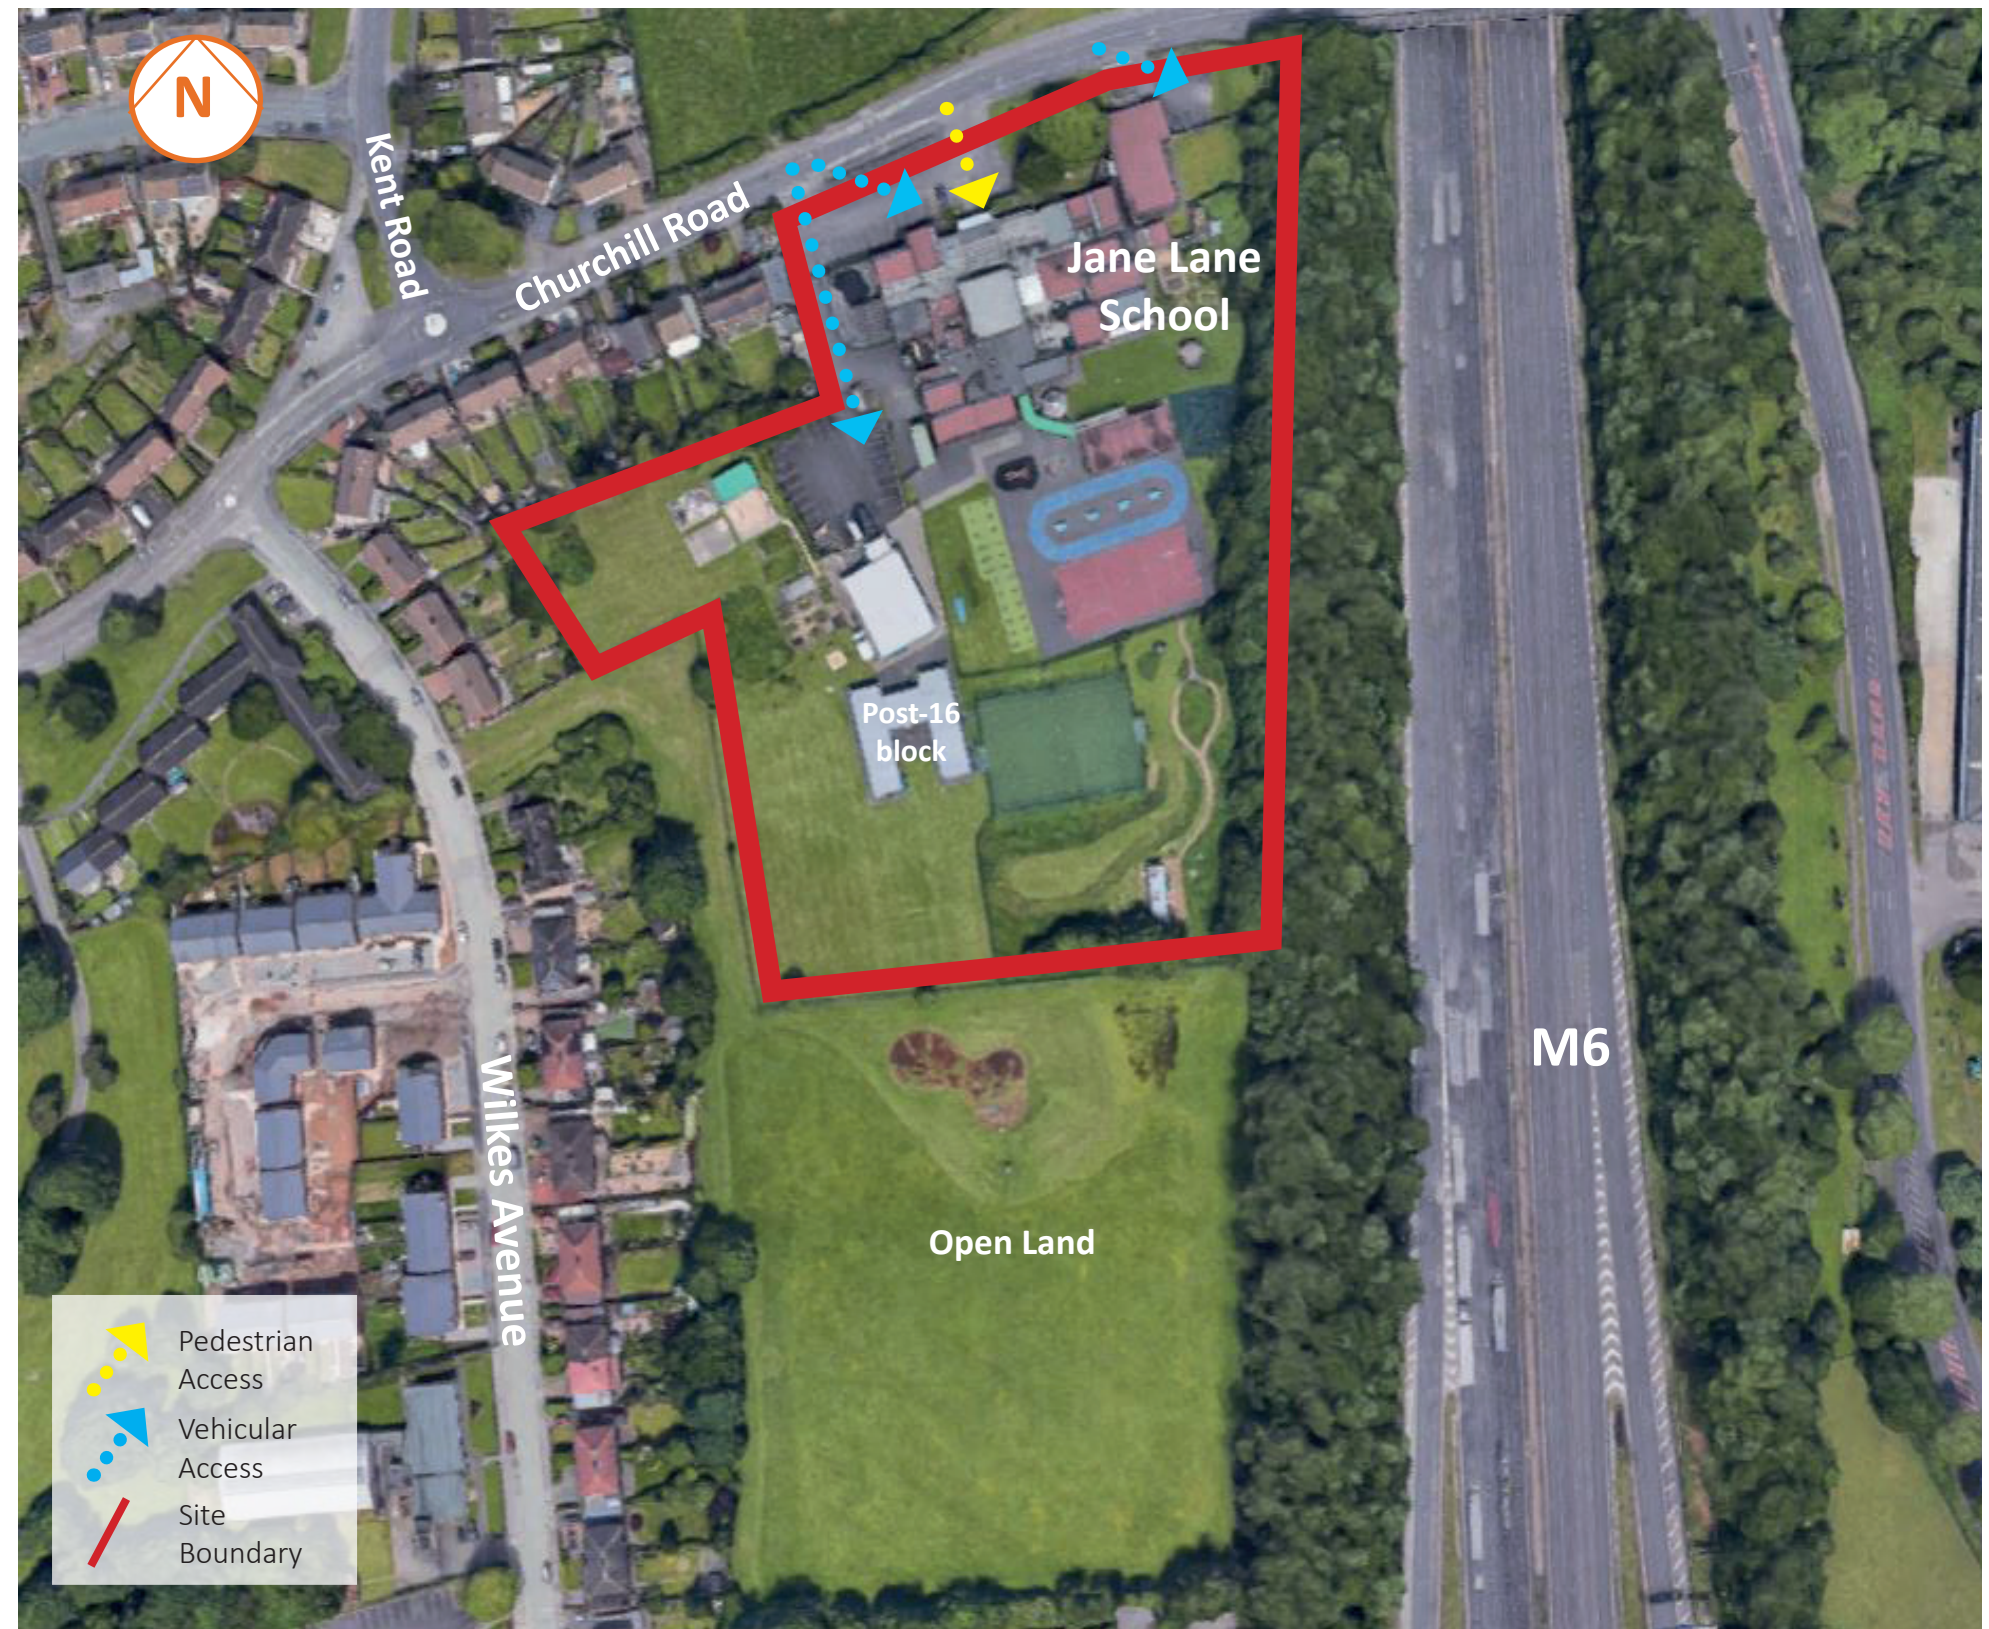
Existing site layout

For information, the open land to the south of Jane Lane school measures circa 12,500 m² which would be more than adequate for a new PRU facility, with opportunity to share facilities.

It is understood the school includes a post-16 teaching block which is vacant and available for re-use. Subject to further review of the accommodation, this building could be considered for offsite specialist teaching provision for the new PRU.

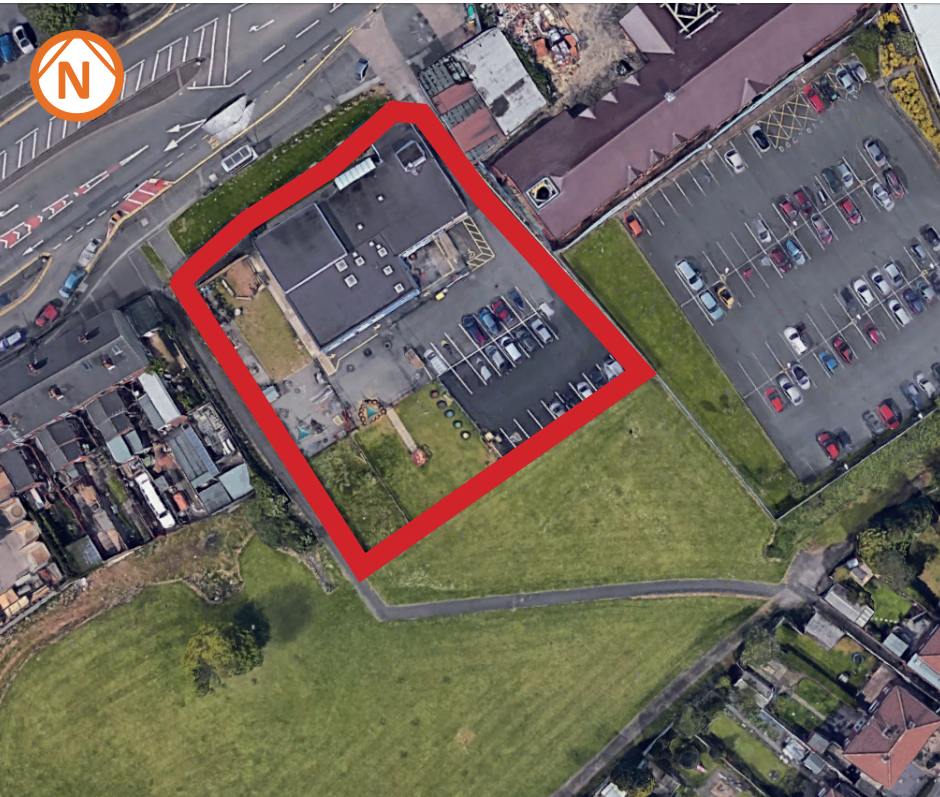
Site 1 - Rowley Robbins

Planned works	Refurbishment and Extension
Site Address	Moxley Road, Wednesbury WS10 7RD
Existing Site Area	2,340 m ²
Existing Buildings Area	432 m ²
Suitability of site / building	<ul style="list-style-type: none">The building and site are too small for a 60 or 80 place provisionThe site could be used for 20 place if extended by 908m²Recommended to demolish the existing and provide a 2-storey blockLimited external space
Occupied or Vacant	Temporarily occupied
Additional Building Area required	The additional building would need extending by 908 m ² (due to the limited site area it is recommended that the existing single storey building is demolished)

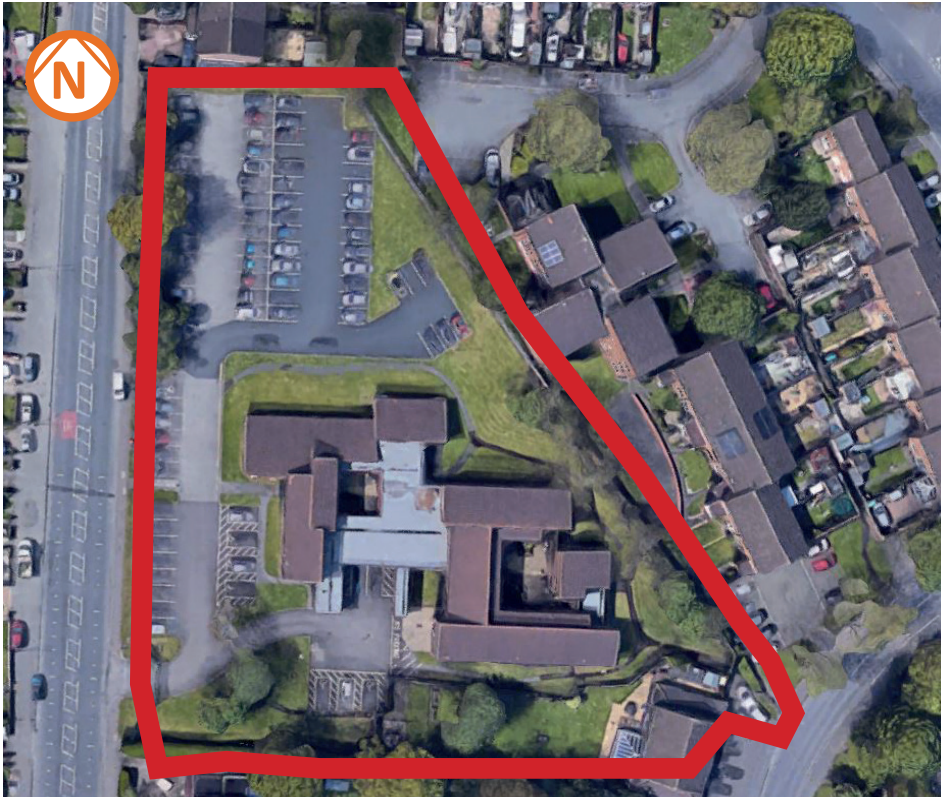
Site 2 - Essington Lodge

Planned works	Re-model and Extension
Site Address	106 Essington Rd Willenhall WV12 5EX
Existing Site Area	6,050 m ²
Existing Buildings Area	1,017 GF and 540m ² FF Total GIFA 1596m²
Suitability of site / building	<ul style="list-style-type: none">Too large for 20 places324m² too small for a 60 place PRU614m² too small for a 60 place PRUBuilding layout not ideal for PRU. Significant re-model required for large spaces. Low level windows would need to be changed.Limited space for extensionLimited outdoor spaceResidential properties in close proximity to the east of the main building
Occupied or Vacant	Currently Occupied by Children's Services
Additional Building Area required	324m ² for 60 place PRU

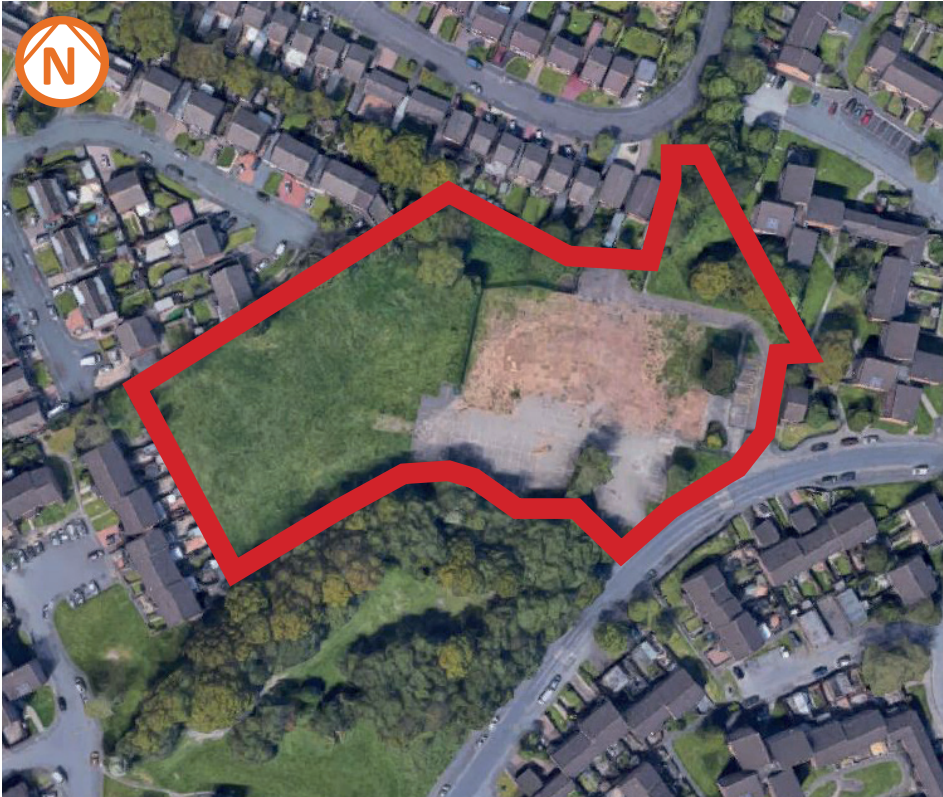
Site 3 - The Allens Centre

Planned works	New Build Site
Site Address	67-63 Hilton Rd Willenhall, WV12 5EX
Existing Site Area	13,074m ²
Existing Buildings Area	N/A
Suitability of site / building	<ul style="list-style-type: none">Additional external area 2194m²The site area has potential to take a 140 place PRU based on BB104 guidelines (without formal team games)Made ground present on site - potential risk of contaminationClose proximity to residential neighbours, this could be a planning issueIs the site better suited to residential developmentInitial findings indicate that this is the only site currently large enough to take an 80 place PRUCould part of the site be retained for residential development (2194m²)
Occupied or Vacant	Vacant Site
Building Area required	2210m ² 80 place PRU

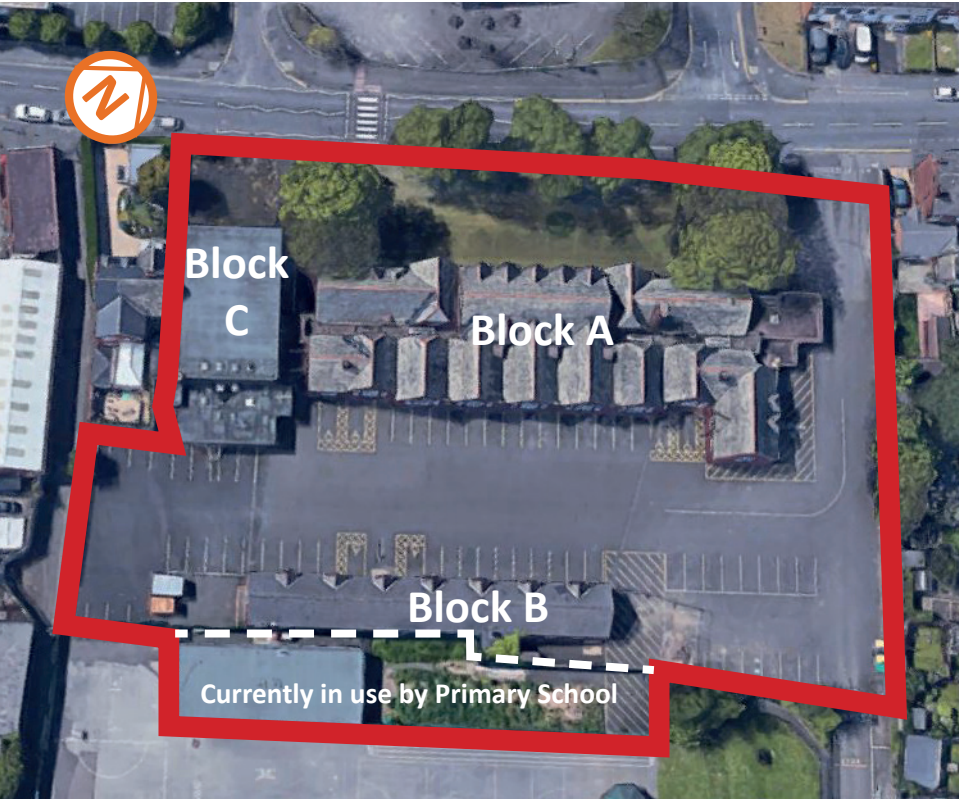
Site 4 - The Education Centre (ESC)

Planned works	Refurbishment and Extension
Site Address	Field Rd, Walsall WS3 3JF
Existing Site Area	5,850 m ²
Existing Buildings Area	Block A 1244 m ² Block B 341 m ² Total 1585 m ²
Suitability of site / building	<ul style="list-style-type: none">Building layout is suitable for educational useBlock A & B are 625m² too small for 80 placesCondemned block C (424m²) could be a suitable area if Block A is extended to increase the GIFAExisting buildings have been vacant and unheated for some time.Condition improvements will be required to external fabric, gutters and downpipes will need replacing.Thermal upgrades are potentially requiredFrom an M&E perspective Block A is in better condition than Block BThe site is in close proximity to the Pinfold Centre - could both sites be used?
Occupied or Vacant	Vacant
Building Area required	625m ² extension required for an 80 place PRU Demolition of Block C - two storey extension of 324m ²

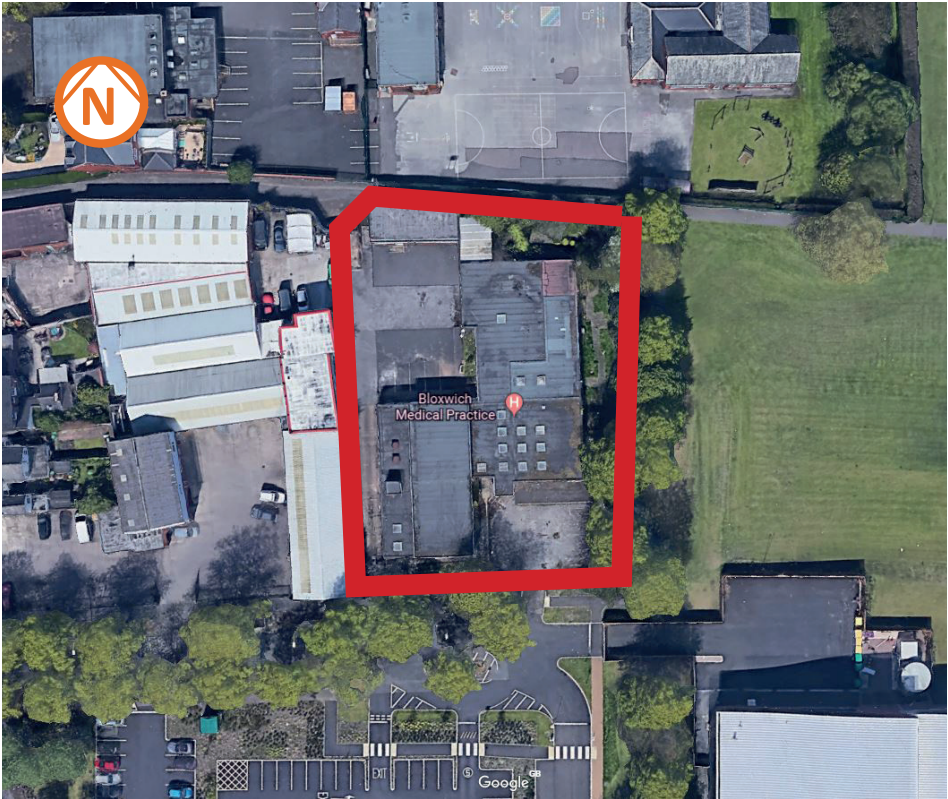
Site 5 - The Pinfold Centre

Planned works	Demolition and New Build
Site Address	Field Road, Walsall WS3 3JP
Existing Site Area	2,800 m ²
Existing Buildings Area	1097m ²
Suitability of site / building	<ul style="list-style-type: none">Building not in suitable state nor large enough.Potential to demolishLimited site areaPotential to link this site with the Education Support CentreMax 20 place PRU (recommended 2 storey to retain areas of external play)
Occupied or Vacant	Vacant
Building Area required	1097m ² Demo, 1340m ² new build required for a 20 place PRU

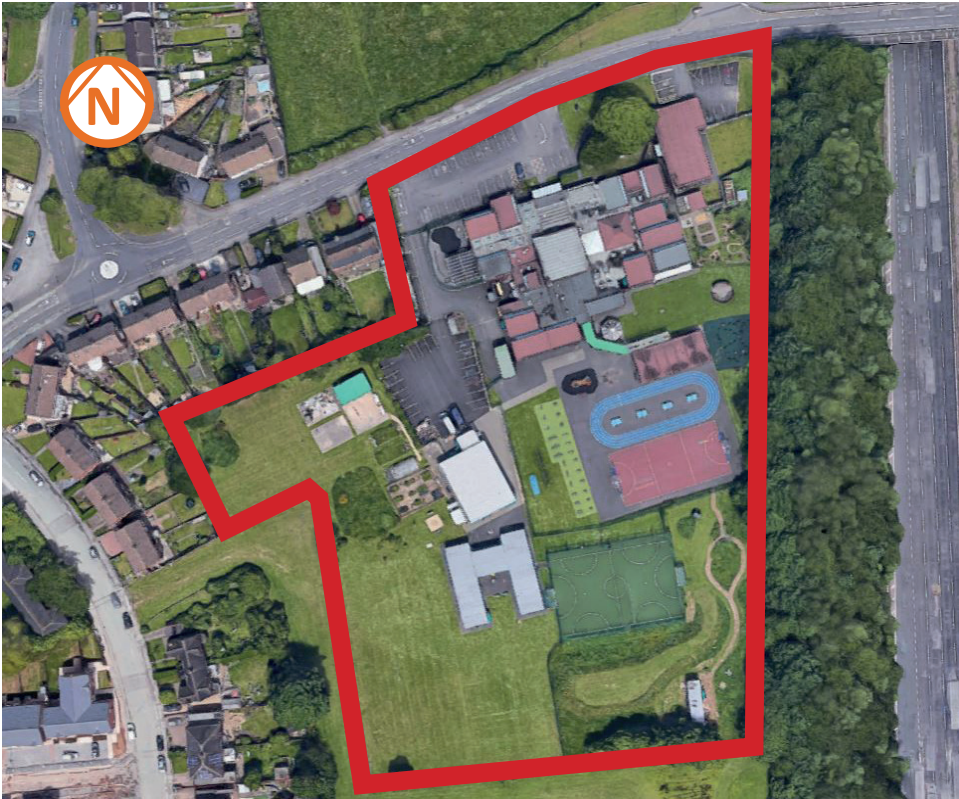
Site 6 - Jane Lane

Planned works	New Build and re-use
Site Address	Churchill Road, Walsall WS2 0JH
Existing Site Area	18,540 m ²
Existing Buildings Area	The existing buildings are in use by Jane Lane School, with the exception of the post-16 block (GIFA c.370 m ²)
Suitability of site / building	<ul style="list-style-type: none">Site area inadequate to accommodate an 80 pupil PRUThe post-16 block could be used as a shared facilityOpen land to the south could be considered for the 80 place PRU - subject to tenure/availabilityPlanning risk / local residents may object to new facility /Highways issuesThe compatibility of the Jane Lane SEND pupils and PRU students would need to be consideredSeparate vehicular and pedestrian access would require consideration
Occupied or Vacant	Occupied
Building Area required	2210m ² 80 place PRU could use the post-16 block subject to review of the accommodation and spec

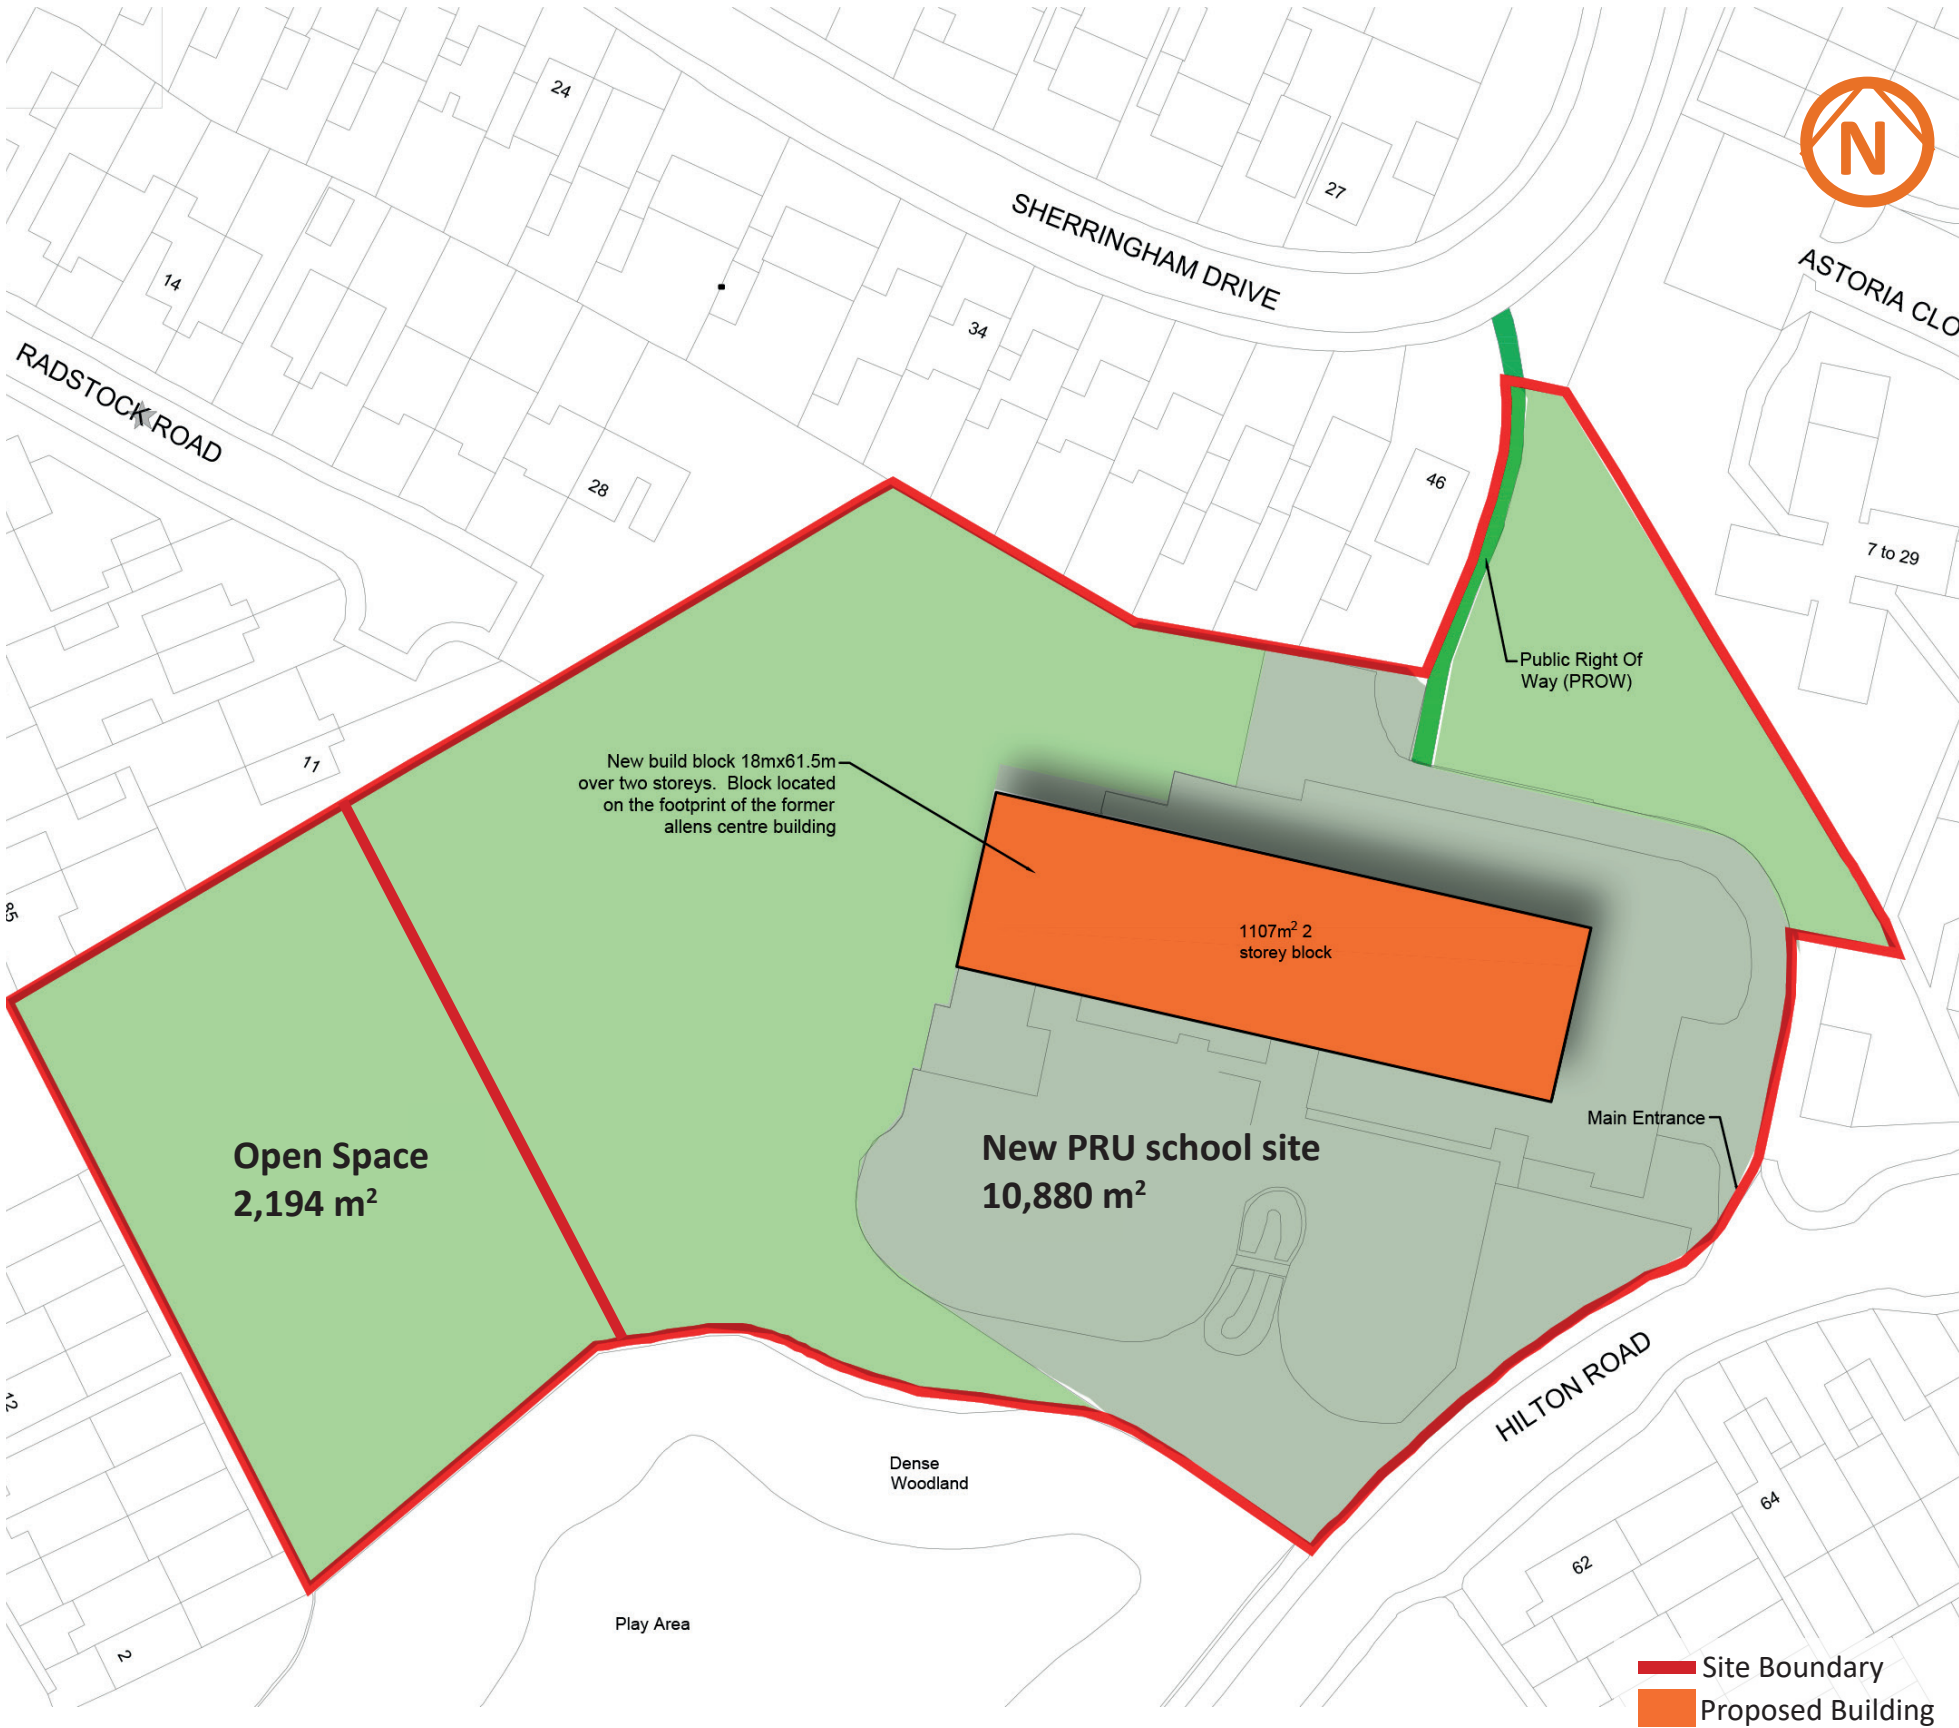
The calculations for increased accommodation have been taken from BB104 requirements for 80no. ambulant primary and secondary students. Total minimum gross area required is circa 2,215m². **A New build two storey building of 1107m² footprint is required.**

It is recommended that the new 2 storey PRU be located on the footprint of the previous building to minimise the impact on local residents. The PROW is retained to maintain pedestrian access from Sherringham Drive onto the site. It is recommended that this access is securely gated and fenced to maintain site security. Provision of parking can be retained to the south. Areas of soft and hard play will be created round the building. The detailed design of this will need to be considered further during RIBA stage.

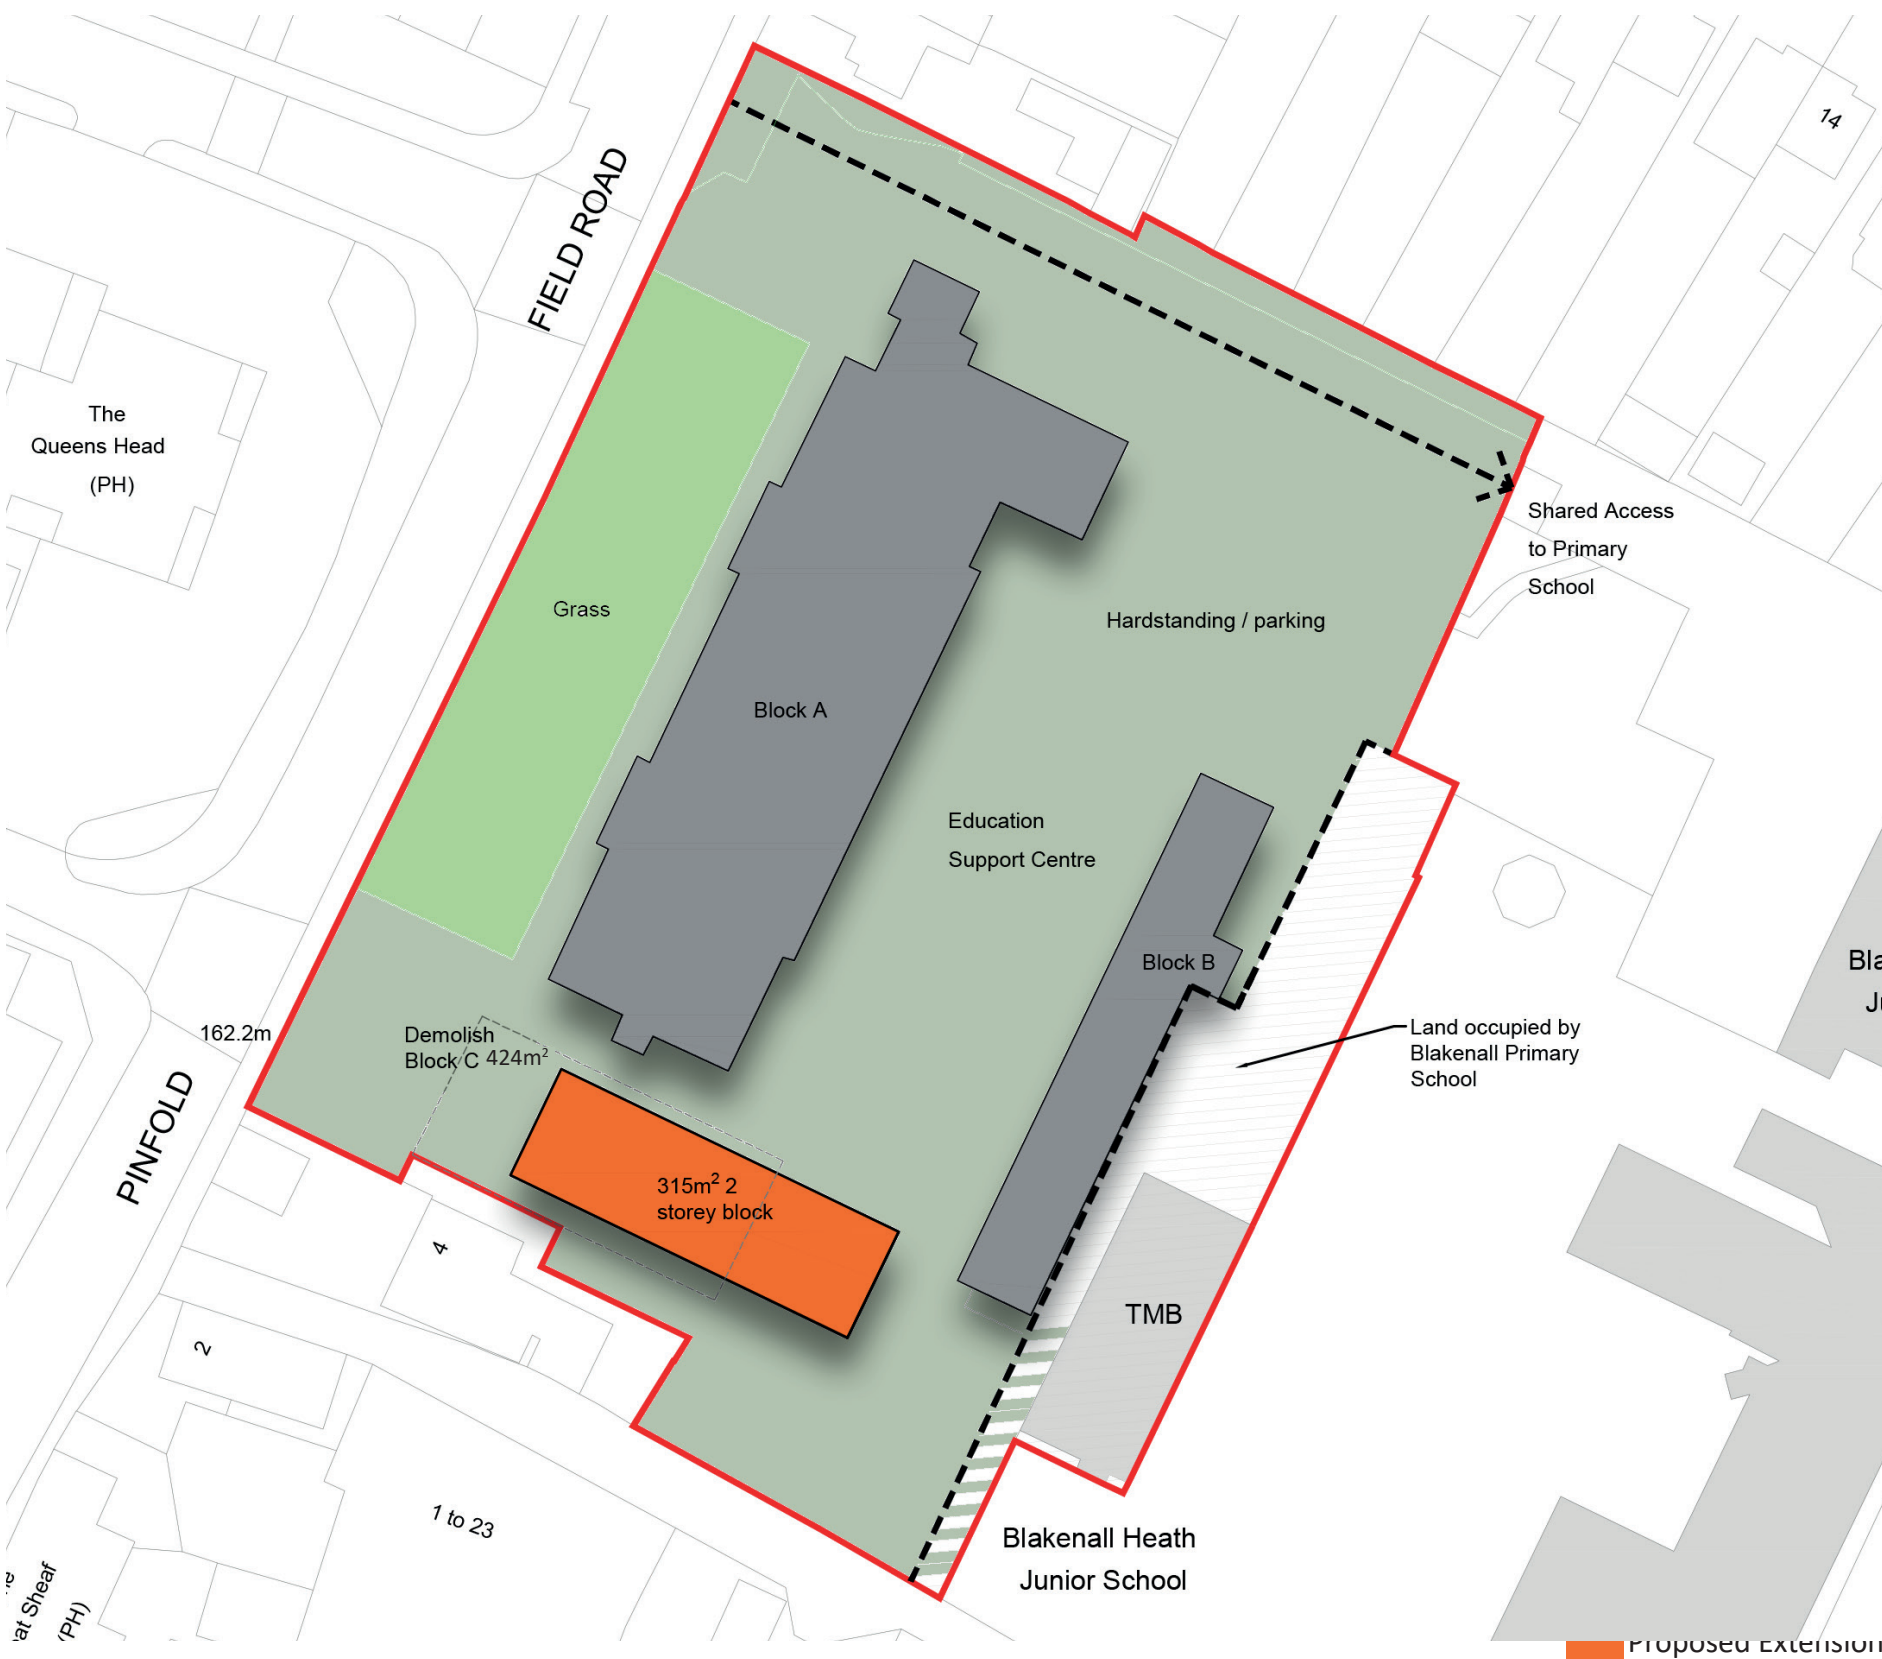
It is recommended that the extension be located around the footprint of Block C. The site shares access with Blackenall Primary School. It is recommended that this access is securely gated and fenced to maintain site security. Provision of parking can be retained although this will need to be reduced to allow for hard outdoor PE. The design of this will need to be considered further during RIBA stage 2.

Building areas: **Block A** 1244 m² | **Block B** 341 m² | **Block C** 424 m²(to be demolished) | **New Build Block** 315m² footprint / 630m² area

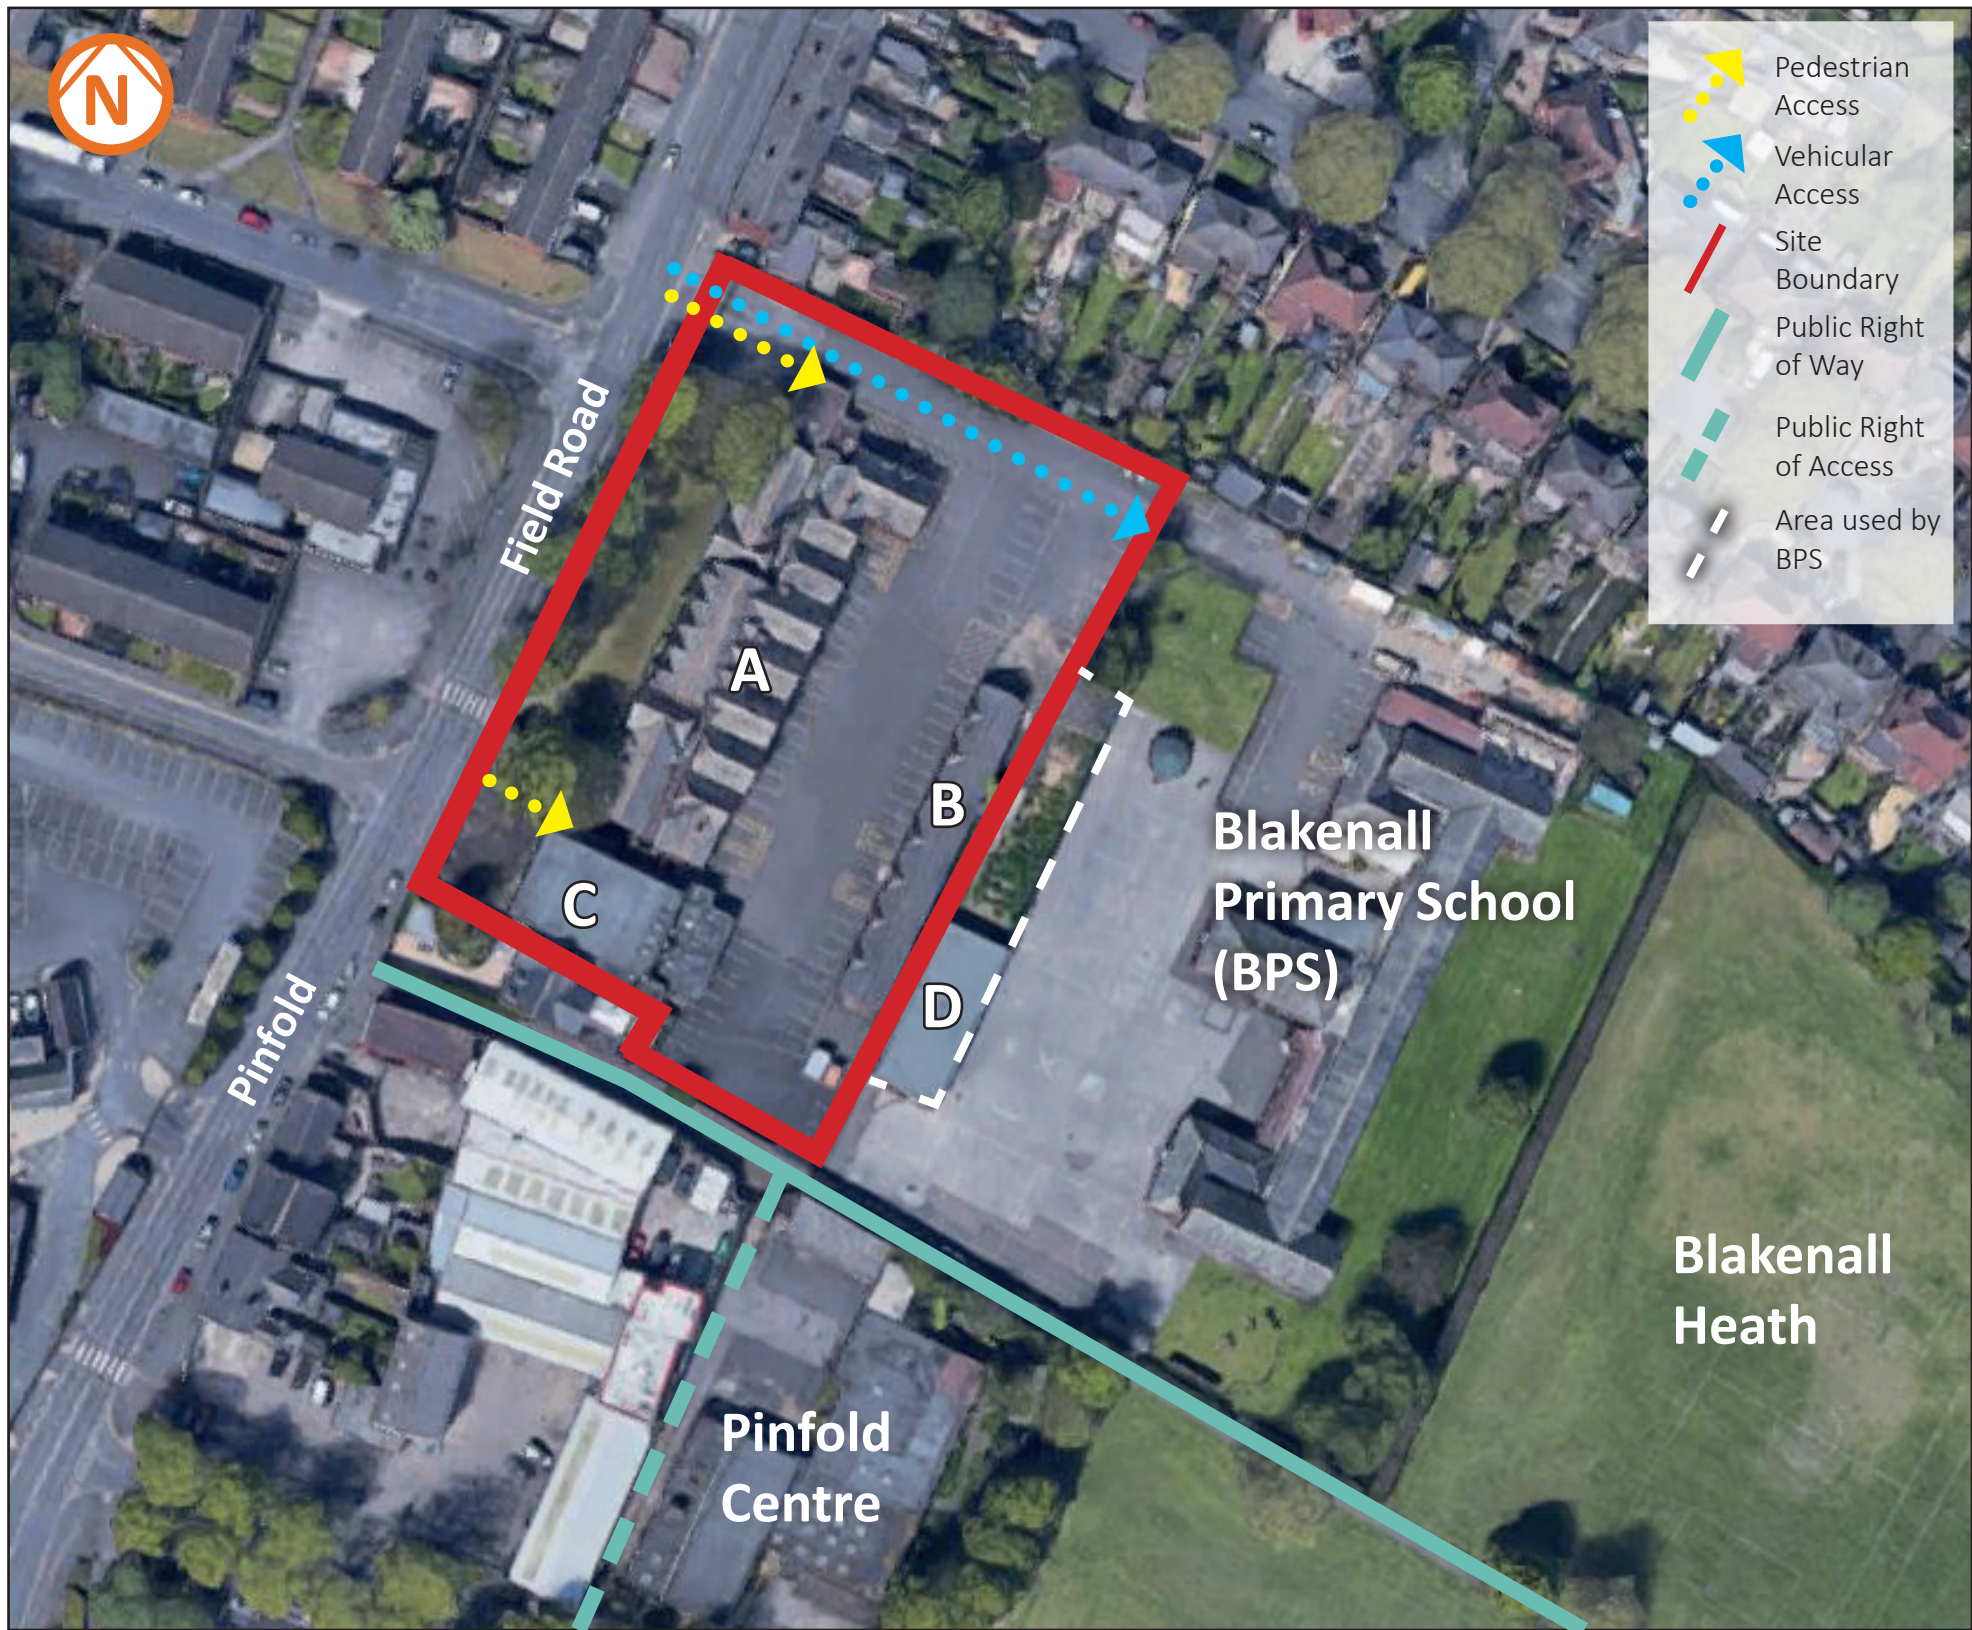
Site Location Plan

This site currently consists of three buildings (referred to as A, B & C within the report). Blocks A & B were inspected during a site visit on 21st May 2019. There was no access to Block C however, it is understood this building is to be demolished.

A - Main Block B - additional accommodation C - Condemned Block D - TMB for Blakenall Primary

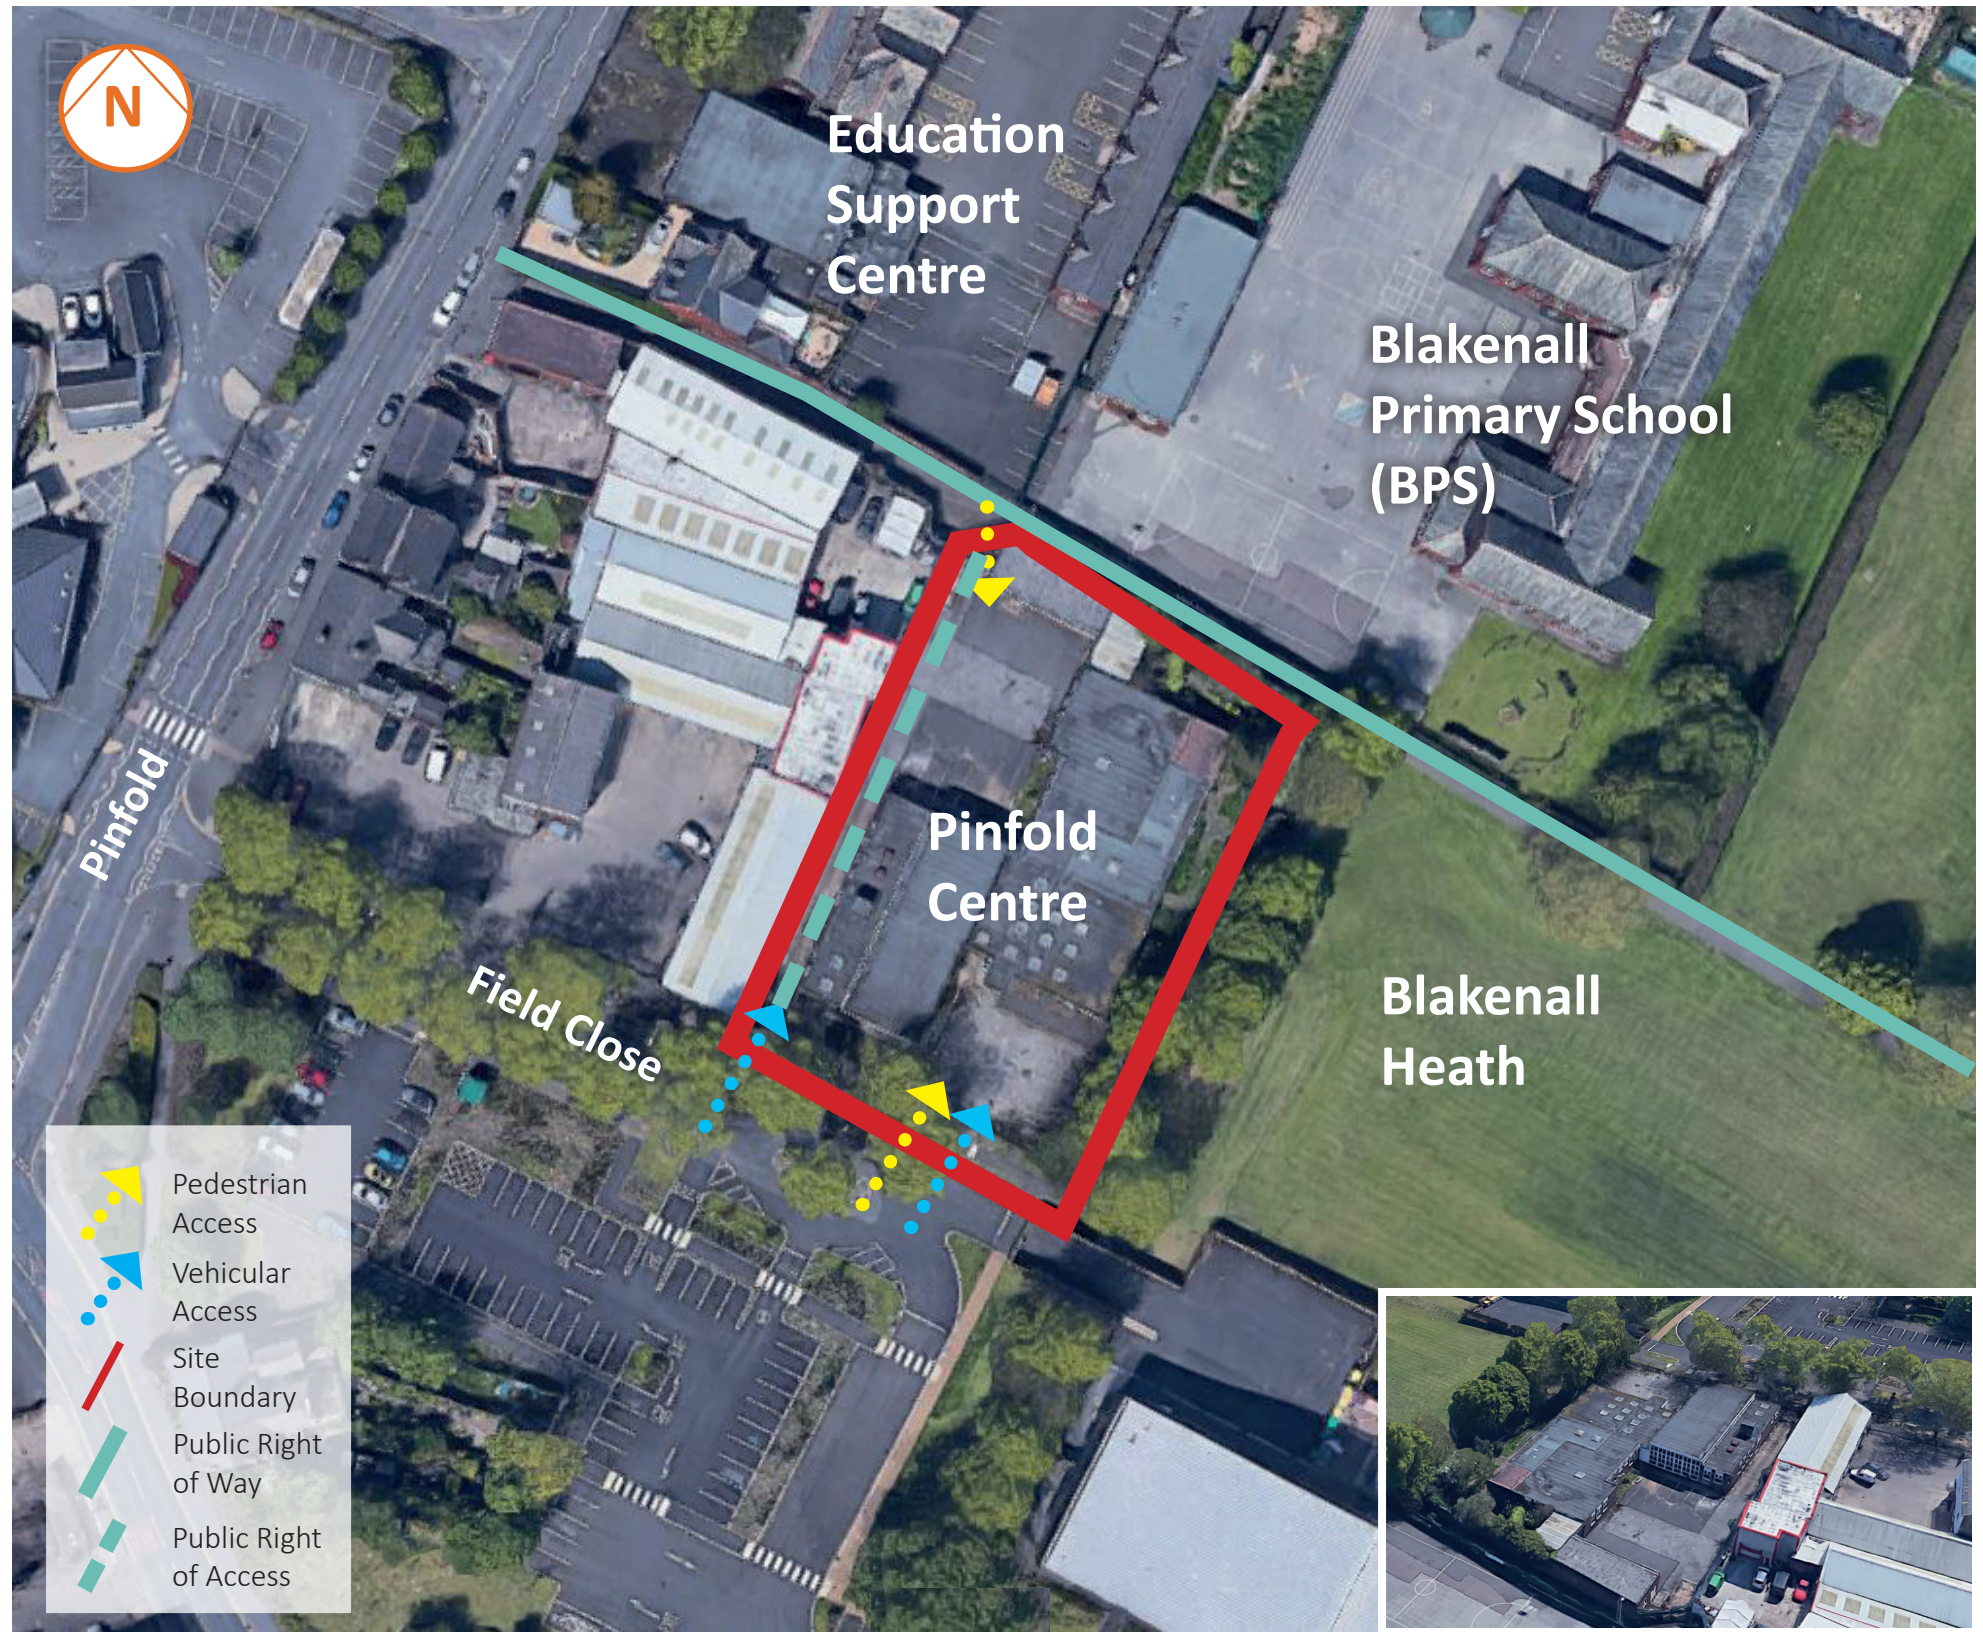
Existing site layout

The total **site area of 2,800m²** falls short of the **10,880m²** required by BB104. This site currently consists of one fire damaged building which is proposed to be demolished. The site has limited play area due to building footprint.

The site has two vehicular access points on Field Close. The main pedestrian entrance is also located on Field Close. During the site inspection it was also noted there was a disused/gated entrance to the north accessed from the PROW.

3D view of the site
