Walsall Pupil Referral Unit

Options Appraisal

RIBA 1 Report

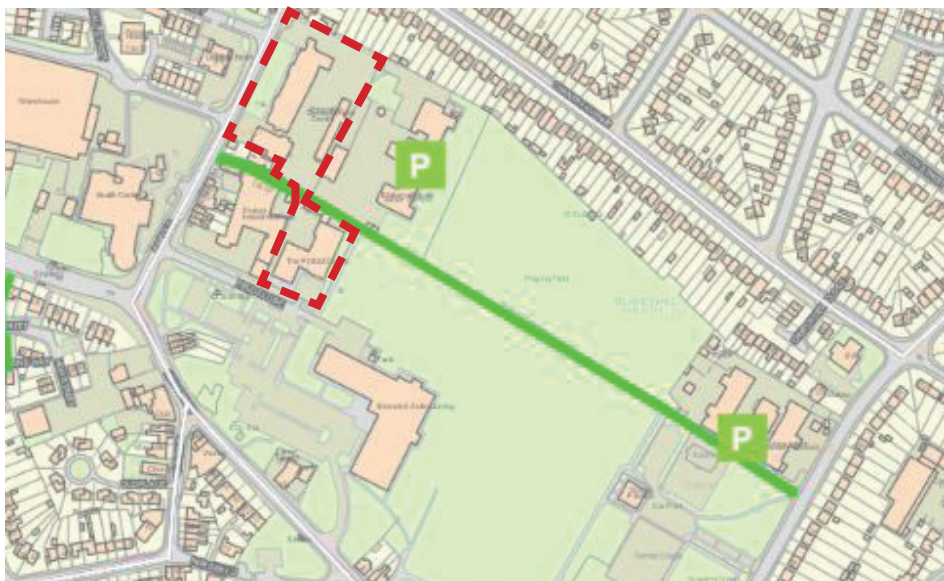
Extract from Walsall Public Rights of Way Map

Site Area:	
Education Support Centre	5850m ²
Pinfold Centre	2800m ²
Additional adjoining land (PROW)	55m ²
Total site area	8705m²

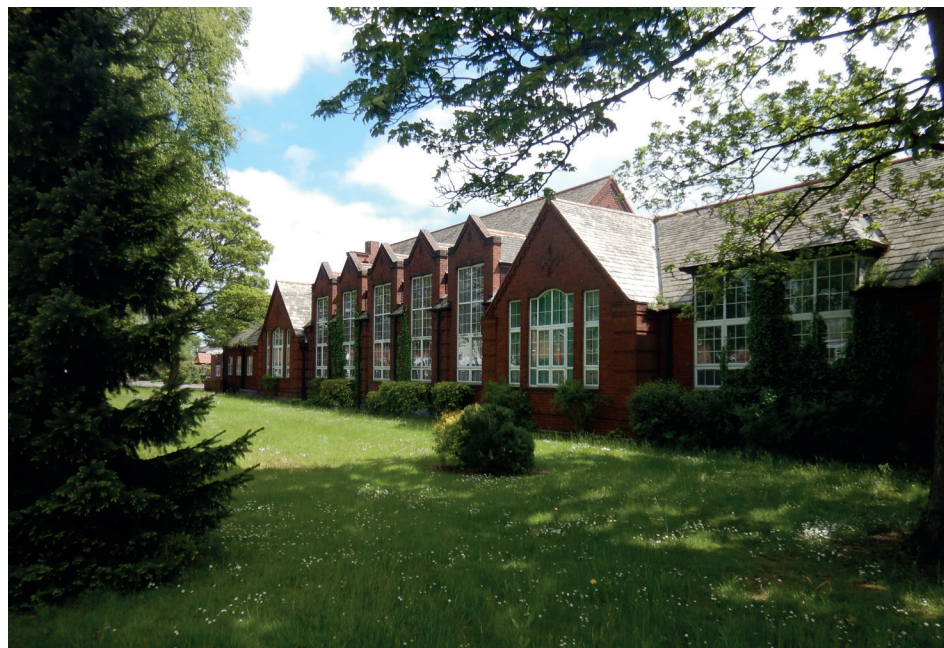
Front Elevation of Block A facing Field Road

The existing buildings are of traditional construction, built with red fair faced bricks laid to an English bond pattern, with brick corbel, dentil and other architectural features. The brickwork is in fair condition though cracking was noted; however, the mortar pointing has failed in numerous locations and needs extensive repointing. Access for repointing to the rear elevation of the smaller of the two buildings is restricted by fencing which will require removal and reinstatement to facilitate any works. As the external walls are solid masonry with no cavity, they will have limited insulating qualities. Plant growth is evident to a number of areas, in particular around rainwater hopper heads, which needs remediation works.

The pitched roof structures are assumed to be timber framed, with steel tie bars and are finished with natural slates and clay ridge tiles.

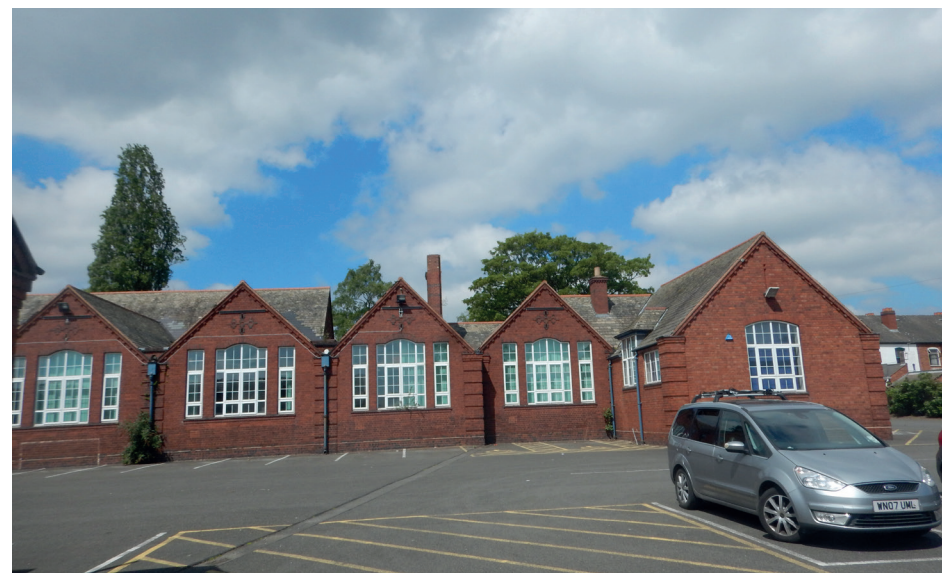
Rear Elevation of Block A facing hard play / car parking

Patch repairing has been undertaken with fibre cement slates, which are unaesthetic when viewed against the original natural slates. The roof coverings are in fair condition, though further detailed inspections are highly recommended as numerous defects are likely to exist, due to the extent of the internal water penetration issues noted. Timber decay as a result of water penetration to the roof structure or similar may also be present, which will need to be investigated further. The rainwater goods are cast iron and are in poor condition, and replacement is recommended with modern polyester powder coated aluminium for durability and reduced long term maintenance expenditure. Insulation

The larger block has a number of flat roof areas which are believed to be all weathered with felt. Anti-climb razor spikes are also installed which restricts access to the flat roof areas. Due to the extensive water penetration issues internally, and directly beneath these areas, repairs will be likely which will need verification via further inspections. Rooflights are also present to the central flat roof area. These rooflights are also suspected to be defective due to the water penetration issues noted in close proximity. The level of insulation to the flat roof areas could also not be ascertained from a visual inspection, and opportunities may exist to improve the thermal performance of the building with increased insulation thicknesses, though this will result in replacement roof coverings.

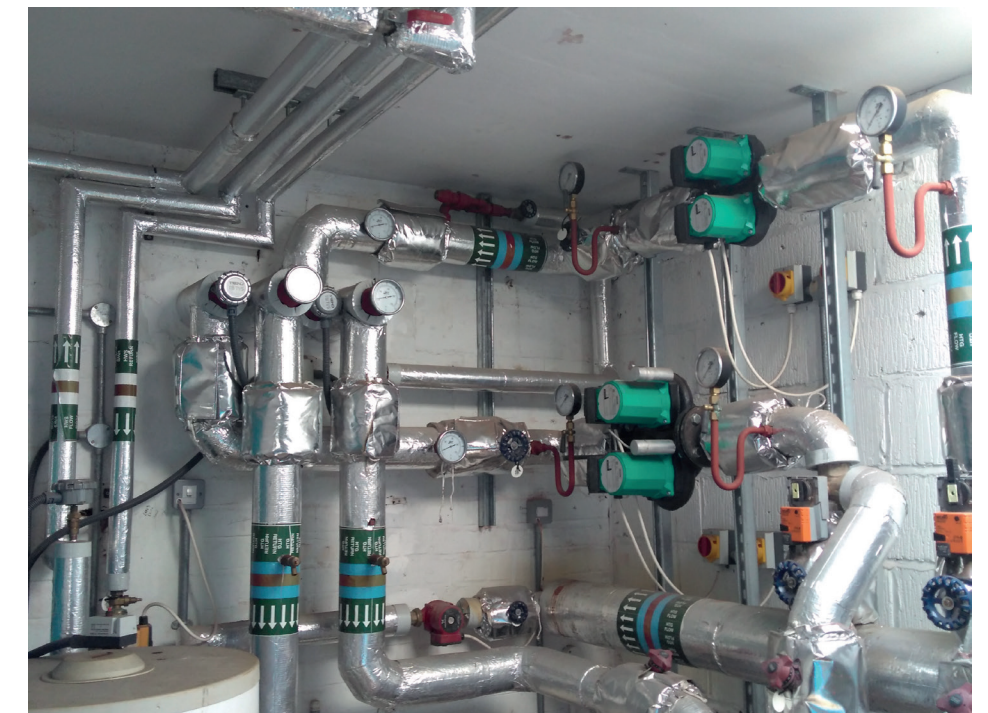
Existing plant room in the ESC

In the larger block 3No. Mikrofill Ethos 90kW boilers were installed in January 2009 as part of the refit and appear in reasonable condition. However, with the building vacant and not used for several years a full system check would need to be undertaken to ascertain the boilers performance. Allowance should be made to replace the boilers if they have not been serviced in accordance with recommended service guidelines. Distribution pipework provide heating to new fan coil units that appear in a reasonable condition. For the smaller block the existing oil boilers are beyond their economic life and require replacement. We would recommend the complete renewal of the heating system and associated equipment, in compliance with Building Regulations Part L 2B. The new system should be designed to suit the new building use and layout.

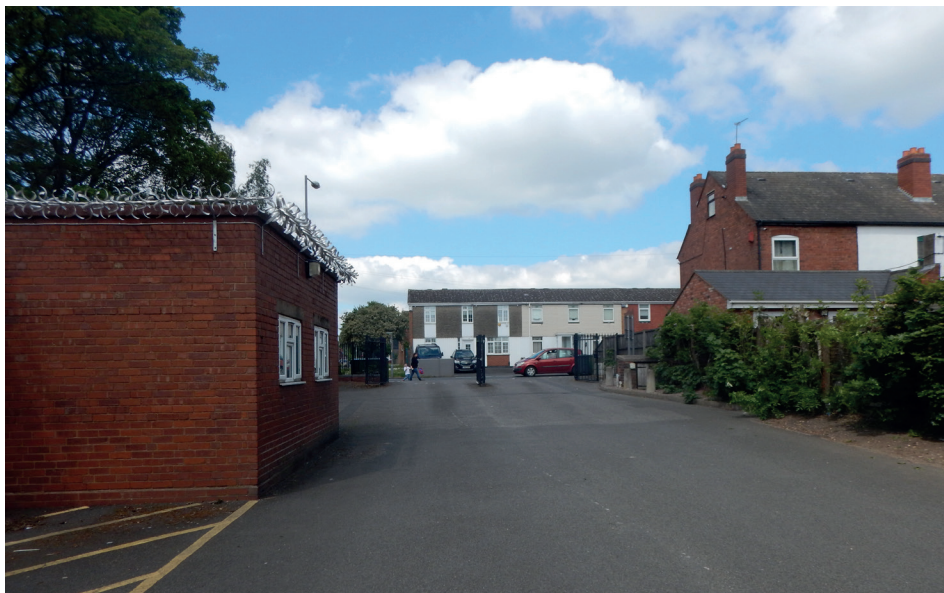
Shared vehicular access with Blakenall Primary School

The total 5,850m² site area of the combined site falls short of the 10,880m² required by BB104. Blakenall Primary school access and drop off requirements will also need to be considered. The area shown by the dashed white line equates to 950m². This further reduces the available site area to 4,900m². On-site staff car parking would further reduce external recreation space and would only offer parking for a proportion of the total PRU staff with others having to park offsite. There is also inadequate space for formal games within the site, therefore offsite / shared facilities would need to be used. Due to the space limitations of the ESC site alone, it is recommended that the combined use of the ESC and Pinfold Centre be selected.
